MOUNT POLLEY MINING CORPORATION POST-EVENT ENVIRONMENTAL IMPACT ASSESSMENT REPORT – KEY FINDINGS REPORT

JUNE 5, 2015

Golder Associates Ltd.
Suite 200 - 2920 Virtual Way,
Vancouver, BC, V5M 0C4

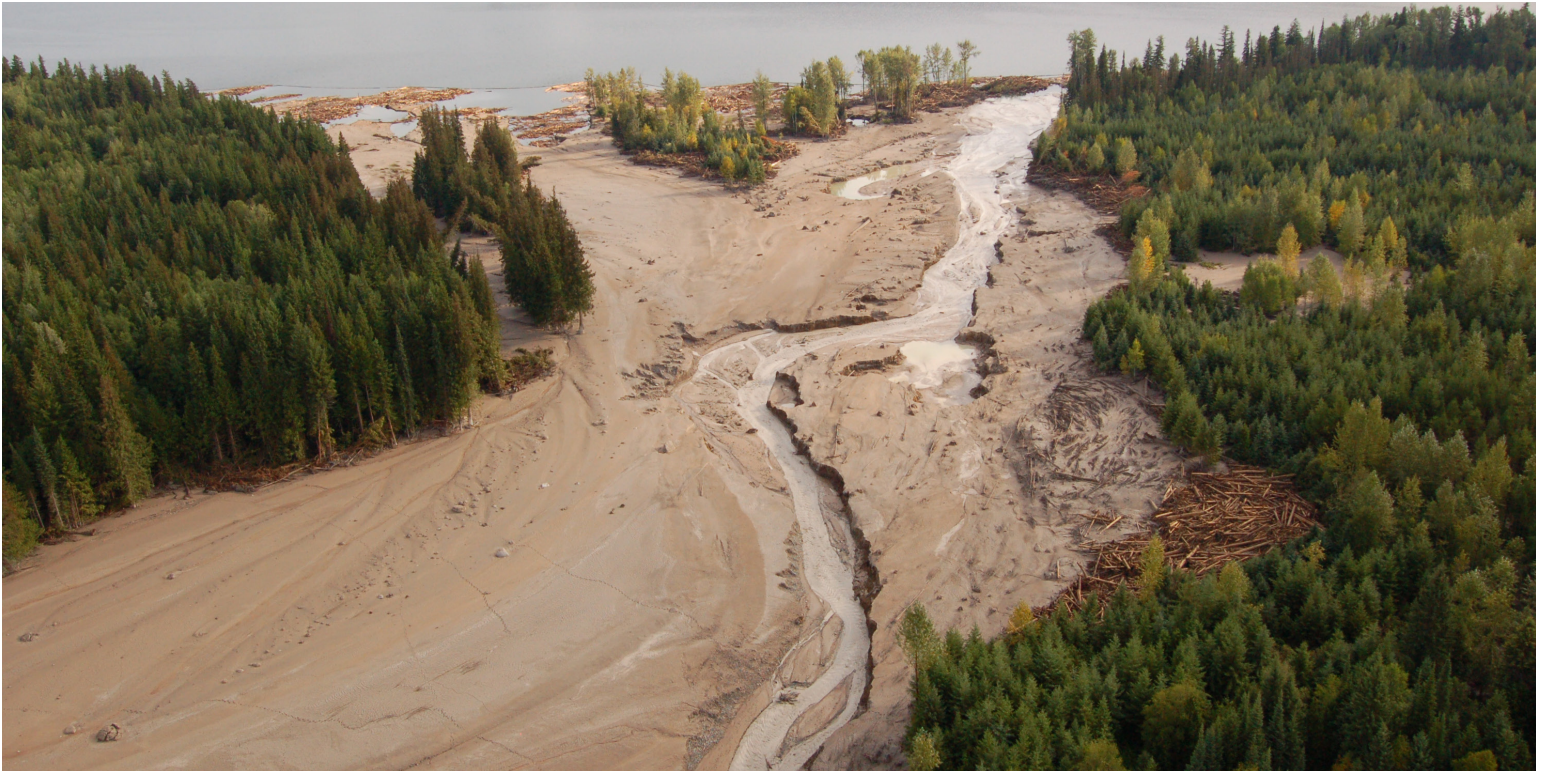
Lower Hazeltine Creek following the tailings dam failure (August, 2014) showing some of the physical changes that occurred

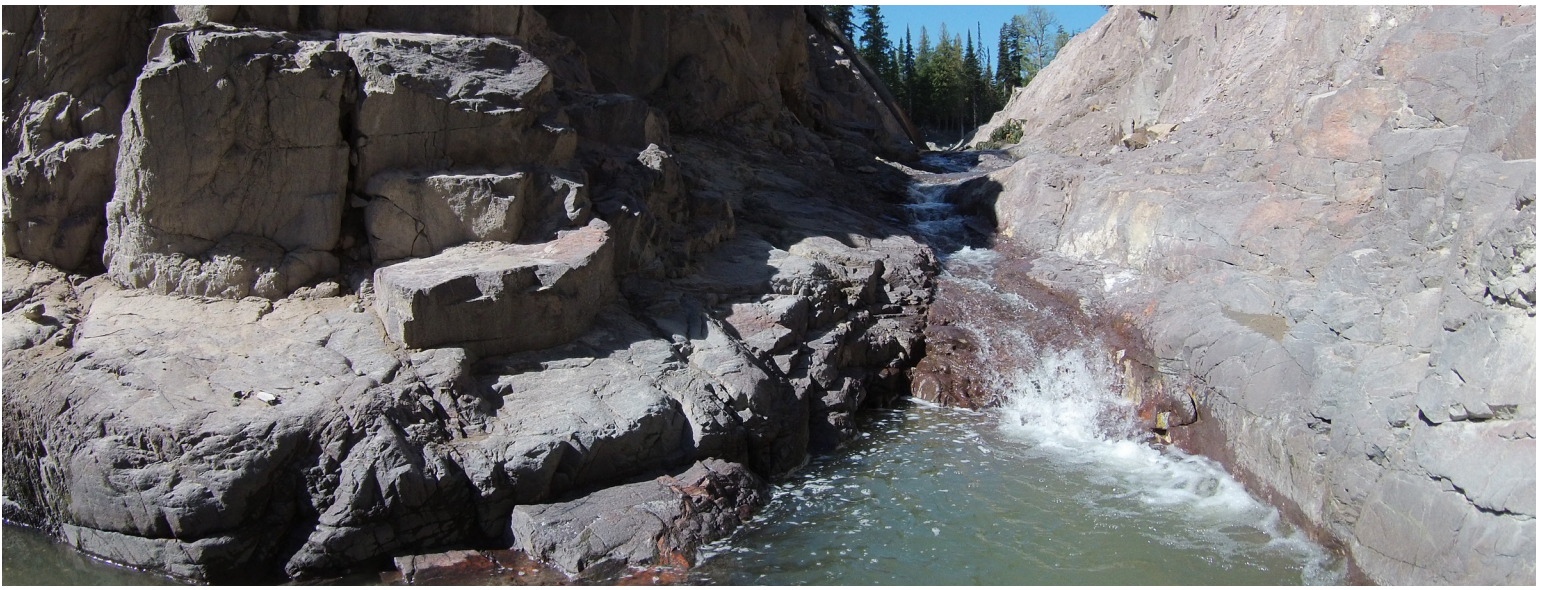
Hazeltine Creek Canyon showing exposed bedrock

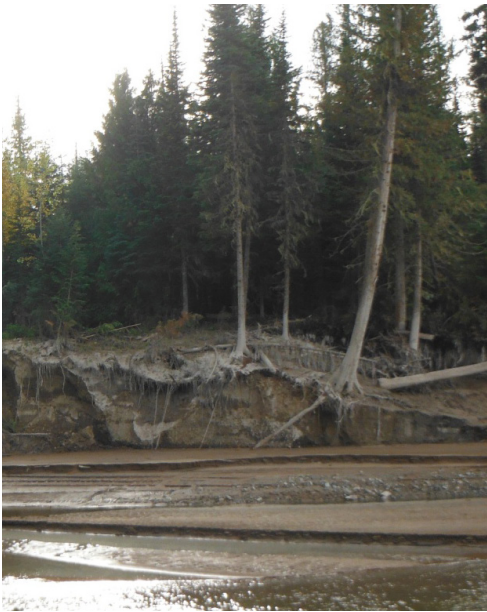
Slope instability and red tailings deposited within the Hazeltine Creek channel (September 22, 2014).

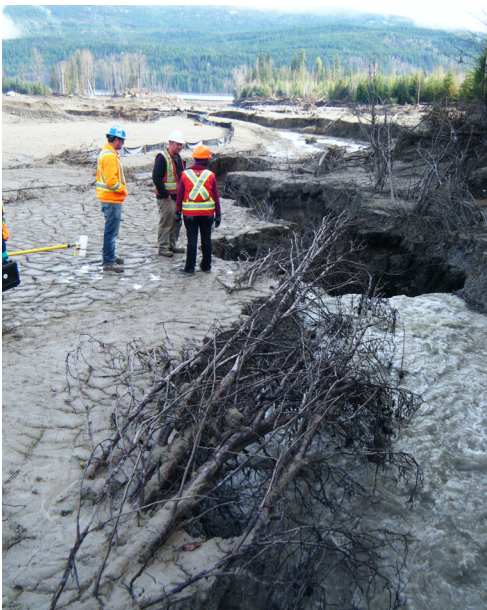
from the debris flow. At the confluence of these two creeks, the Edney Creek bed was scoured, resulting in a drop of about 2 m in elevation, providing a barrier to the free movement of fish from Quesnel Lake to Edney Creek.

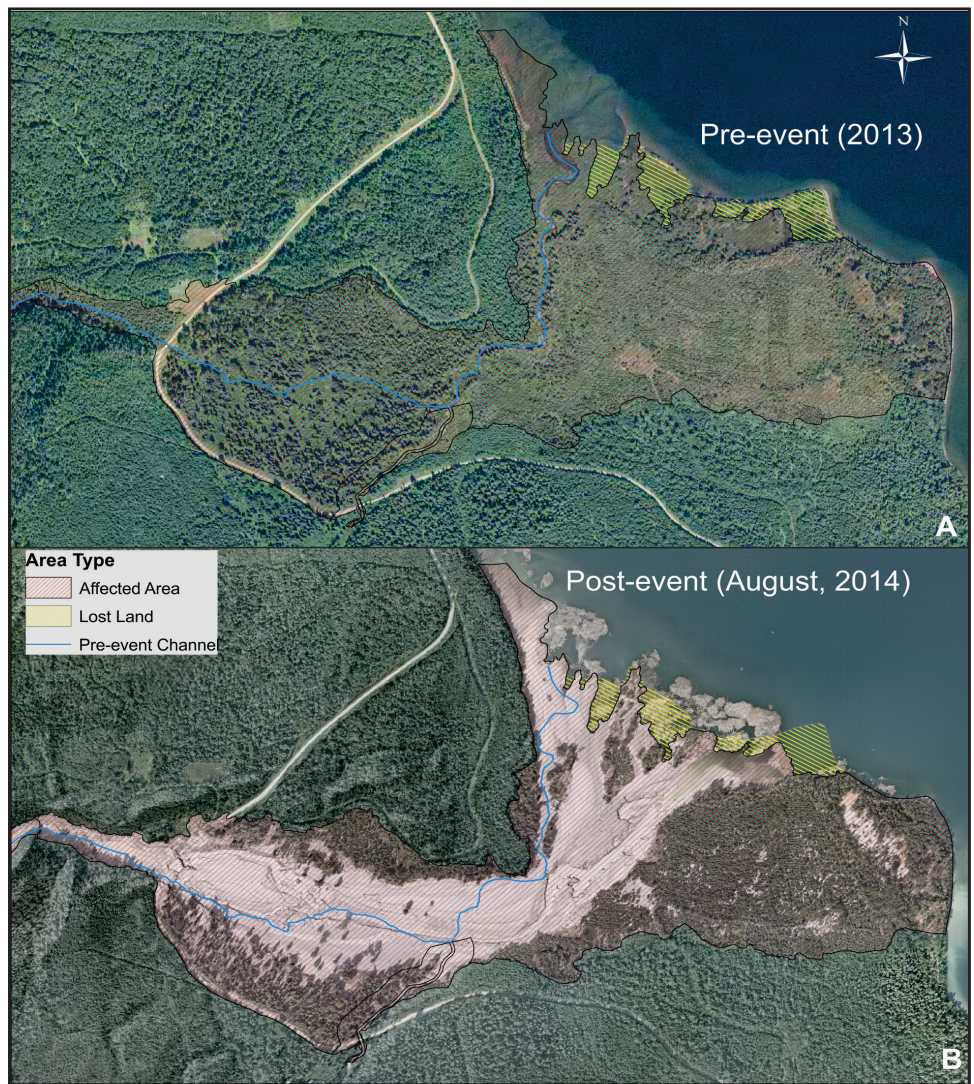
Figure 4: Pre- (A) and post-event (B) view of Hazeltine Creek delta Source: GoogleEarth

Water and tailings released from the dam failure created a debris flow that eroded the channel and floodplain of Hazeltine Creek. The area affected by the debris flow extends from the tailings dam downslope to Hazeltine Creek, upstream to Polley Lake and downstream to Quesnel Lake (Figure 4).

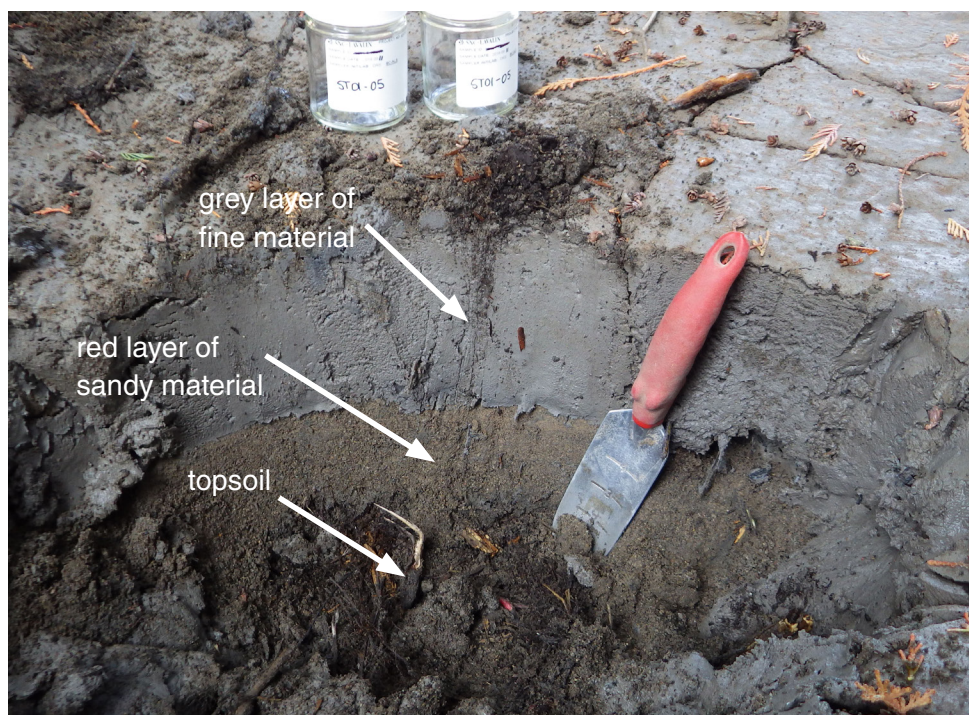
In some areas along Hazeltine Creek, the tailings settled in two layers over the native organic layer. The grey fine tailings settled out over the red-black sand. The concentrations of metals in the two layers were found to be similar.

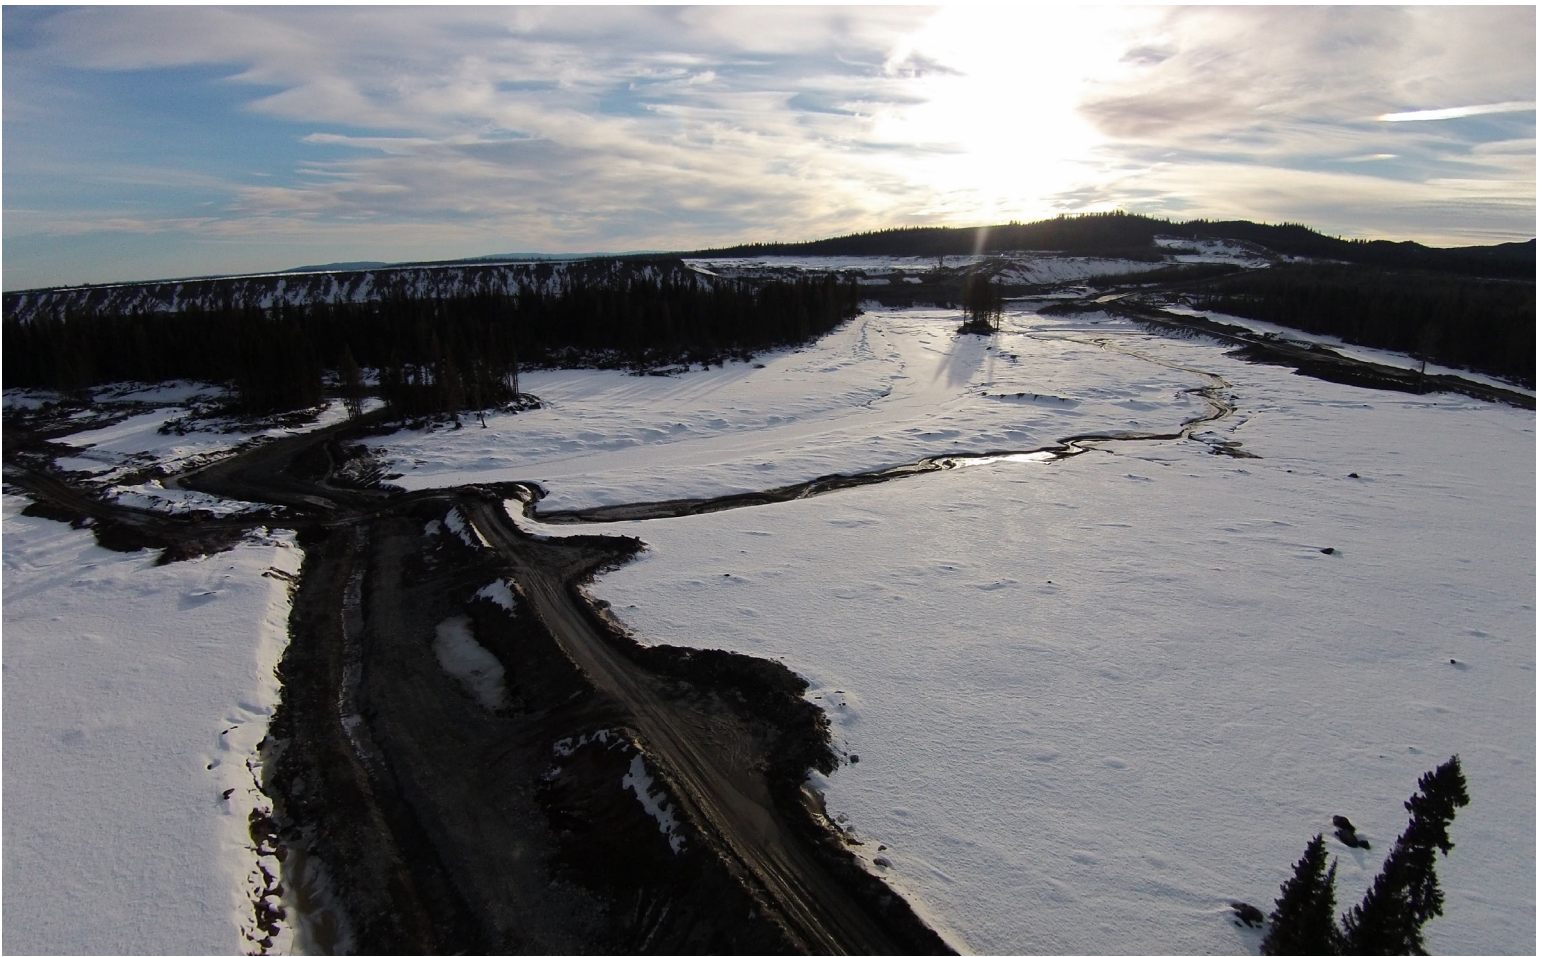
Reach 1 of Hazeltine Creek being constructed in the Polley Plug area

The physical conditions that were left immediately following the dam failure are no longer present. MPMC have been implementing their restoration and remediation strategy and have removed tailings and soil from Lower Hazeltine Creek, constructed the Hazeltine Creek bed, installed sedimentation ponds and corrected the connection between Edney Creek and Quesnel Lake to enable free movement of fish between these two aquatic habitats. The restoration work in these areas is ongoing and progress updates will be provided in the Long Term Human Health and Ecological Risk Assessment in Phase III of their Strategy.

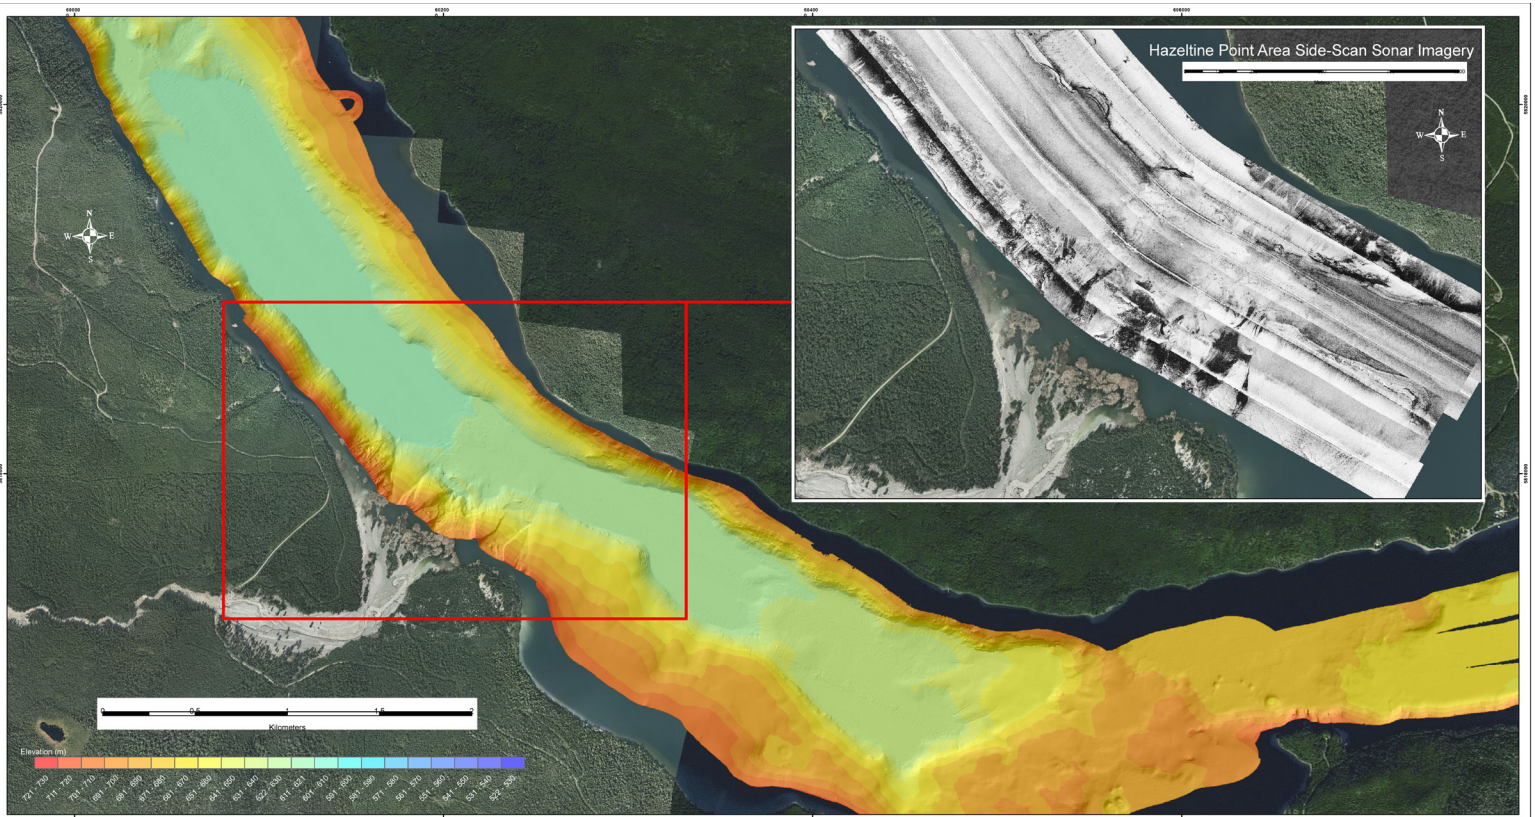
Figure 6: Multi-beam and sidescan sonar image of the bed of Quesnel Lake, near Hazeltine Creek

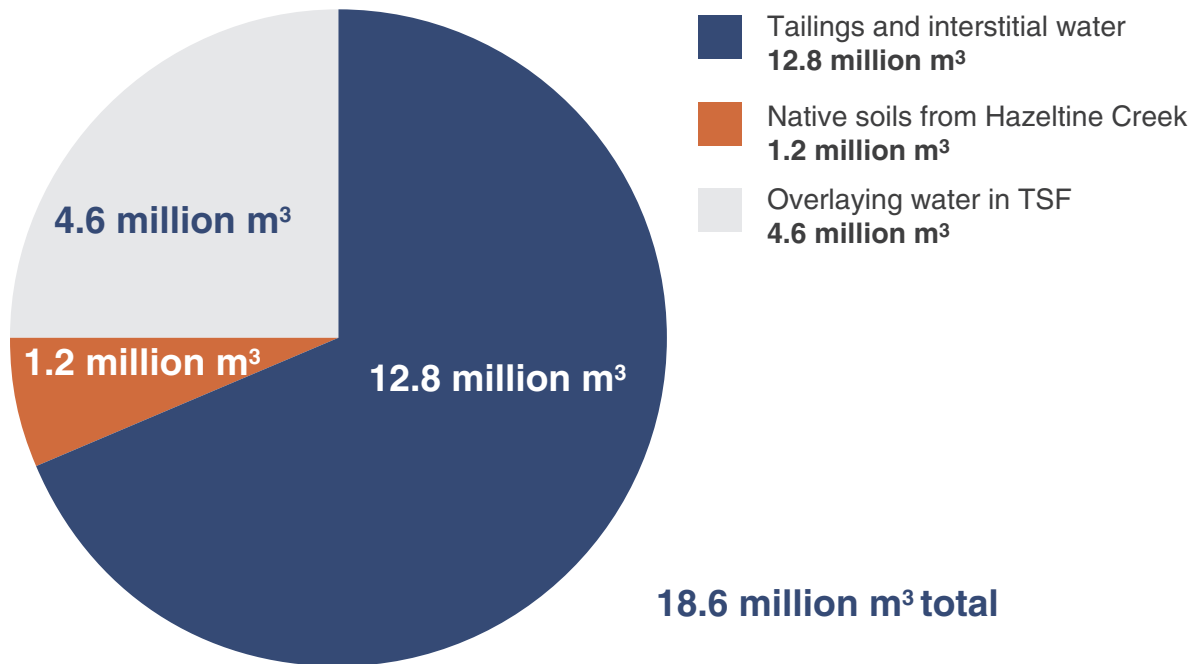
Using this information, Tetra Tech EBA estimated that 18.6 ± 1.4 million m³ entered Quesnel Lake. The breakdown of that material is shown in Figure 9. Most of this material deposited deep in the West Basin, below 100 m depth. The area of that deposit was estimated to be approximately 1.81 km². In some places the deposited material was estimated to be up to 10 m thick; however, those estimates were done soon after the spill and that depth is expected to decrease as the sediments consolidate/dewater/compact with time. For Polley Lake, the pre-tailings dam failure data does not allow an interpretation of post breach data.

This material on the lake bed resulted in a change in the lake bottom habitat and a disruption in the community of small animals that live in the deep lake bed. This impact is part of ongoing studies but early sampling suggests that some recovery of those organisms may have already begun. Sampling of those bottom-dwelling organisms following that deposition and settling of the sediments is necessary to verify expectations that the sediments will recover their function.

Figure 9: Sediment into Quesnel Lake

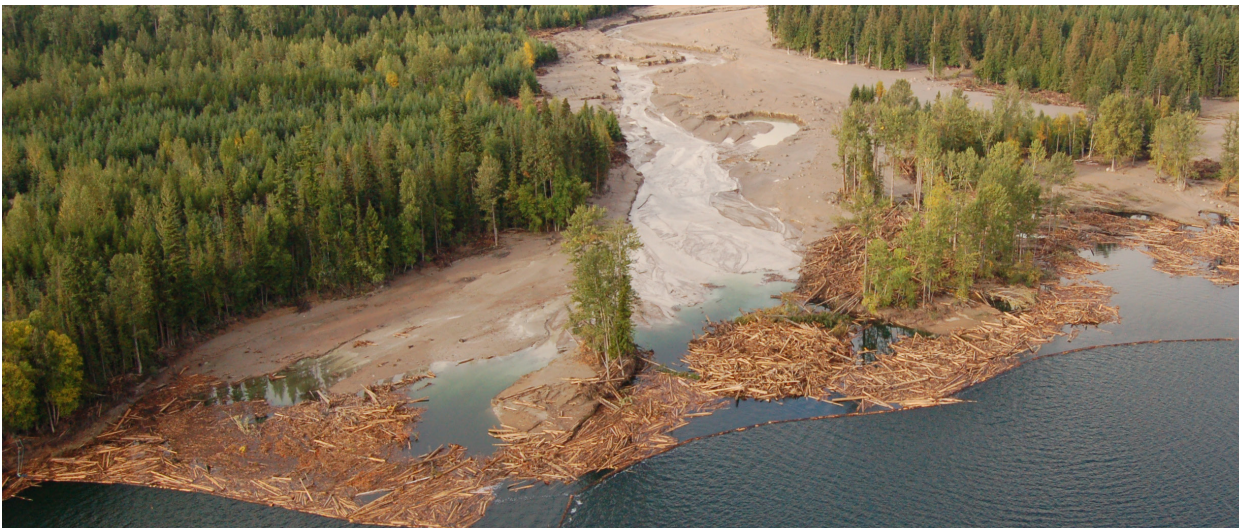
An August 2014 photograph of Hazelmine Creek showing the location of outflow that sank to the deeper parts of Hazelmine Creek, leaving a mostly clear Quesnel Lake surface until fall turn over

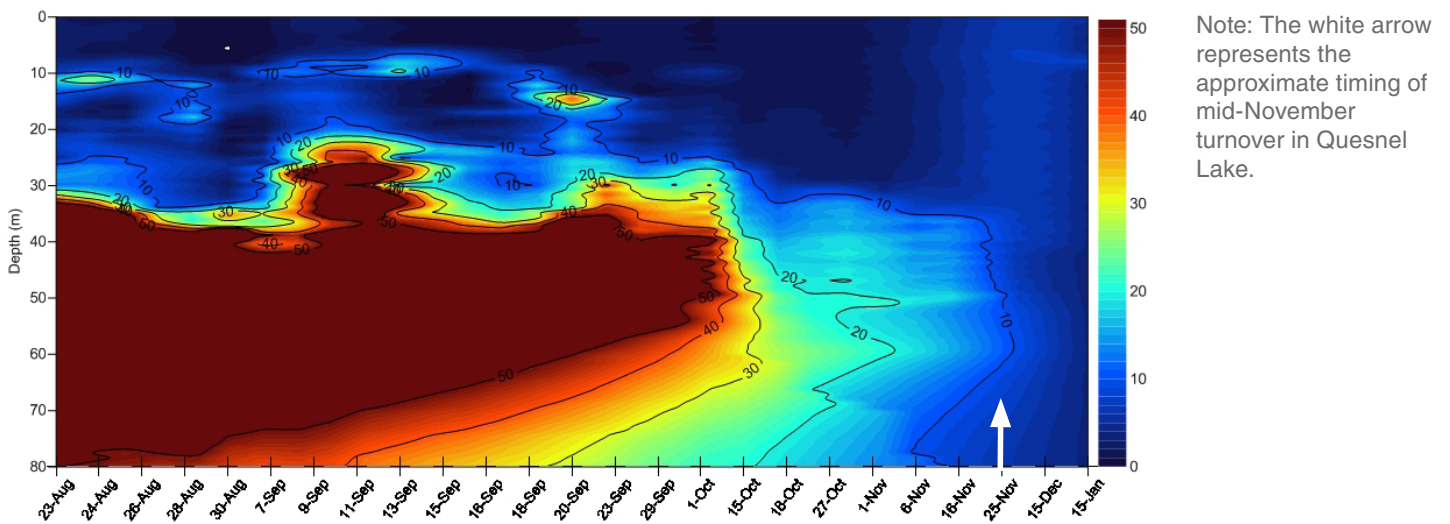
The cloudy water in the western basin began to clear through winter and into spring with clear water inflows and cloudy water outflows through Quesnel River to the west and, to the east past Cariboo Island at depth along a water current induced by internal waves in the lake called seiches. For the suspended material that did not settle, a computer simulation model of Quesnel Lake water movement was used to estimate that approximately 15–20% of the suspended

Figure 11: Turbidity measurements of Quesnel Lake water from the surface to the bottom of Quesnel Lake at a station adjacent to the mouth of Hazeltiline Creek, showing the clearing of turbid water that happened over time

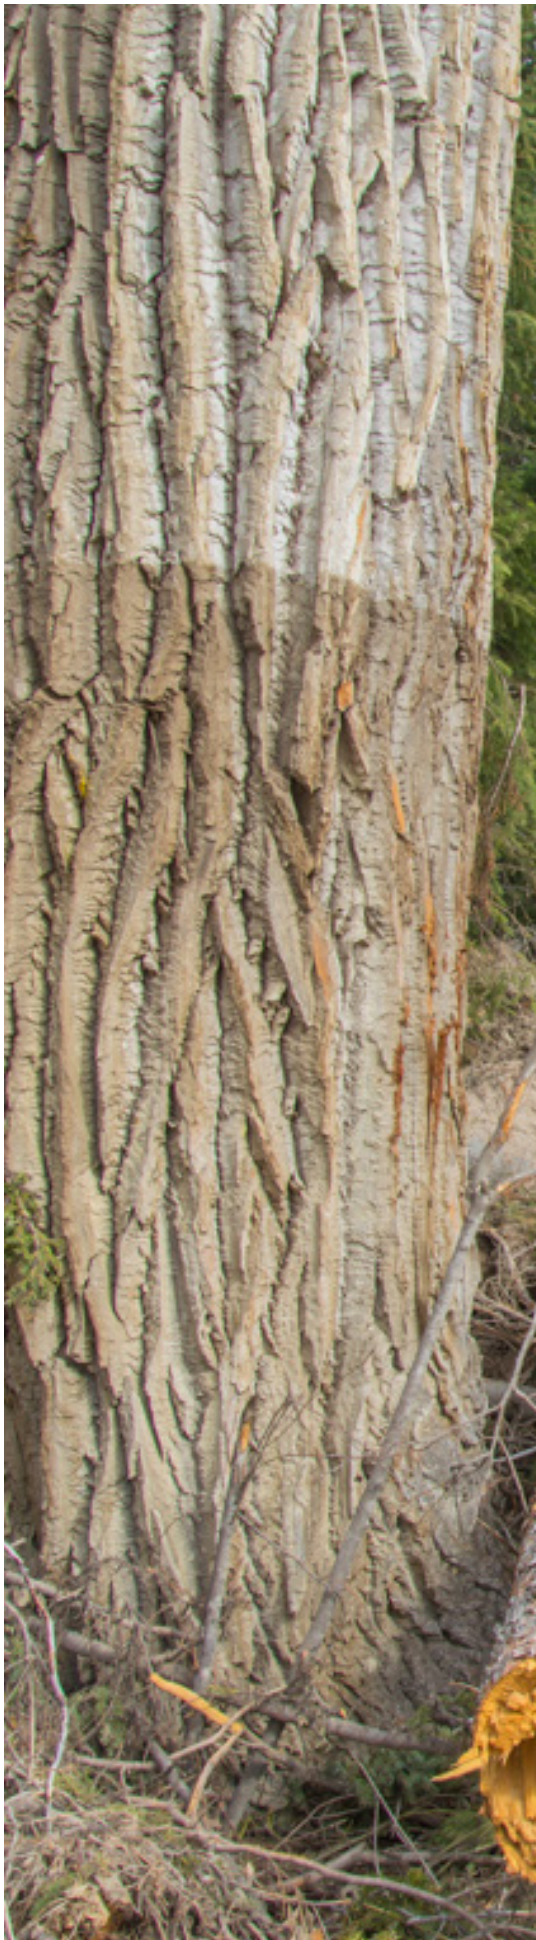
Old growth cottonwood showing the height of debris flow

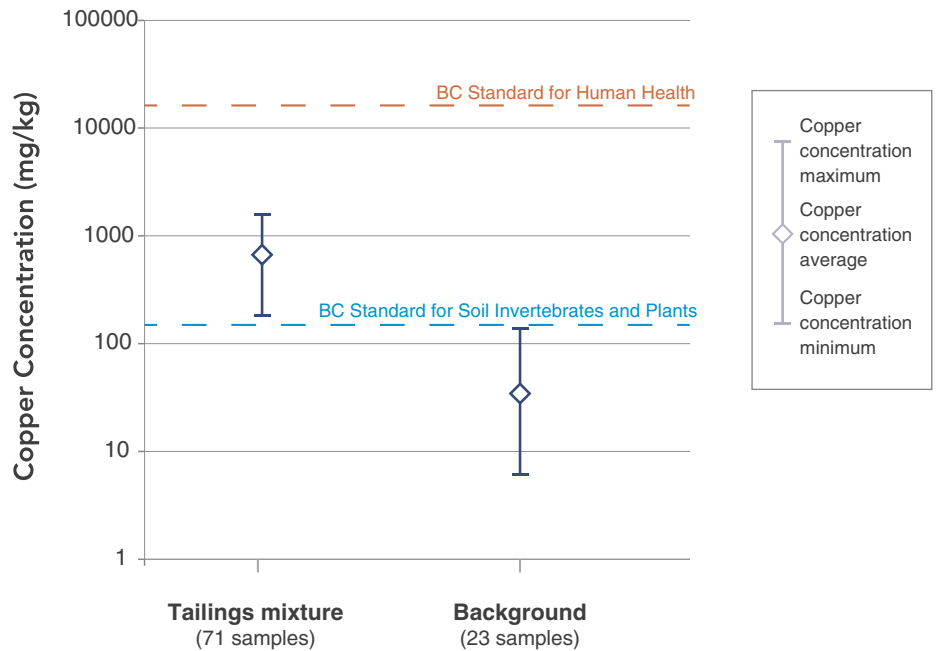
Eighty-eight samples of the tailings soil mixture and twenty-three background soil samples were collected from 18 transects along the Hazeltine Creek channel to evaluate the quality of the tailings mixture in the soil impact assessment. Consistent with the mineral mixture of the tailings discussed previously, the concentrations of copper in the tailings mixture are higher than in the native soil alone, and higher than the BC Soil Standard for the protection of soil invertebrates and plants. The copper concentration in soil is far below the standard for the protection of human health meaning that the tailings mixture is safe for direct human contact.

Figure 12: Copper concentrations in the tailings mixture from Hazeltine Creek area compared to background soil

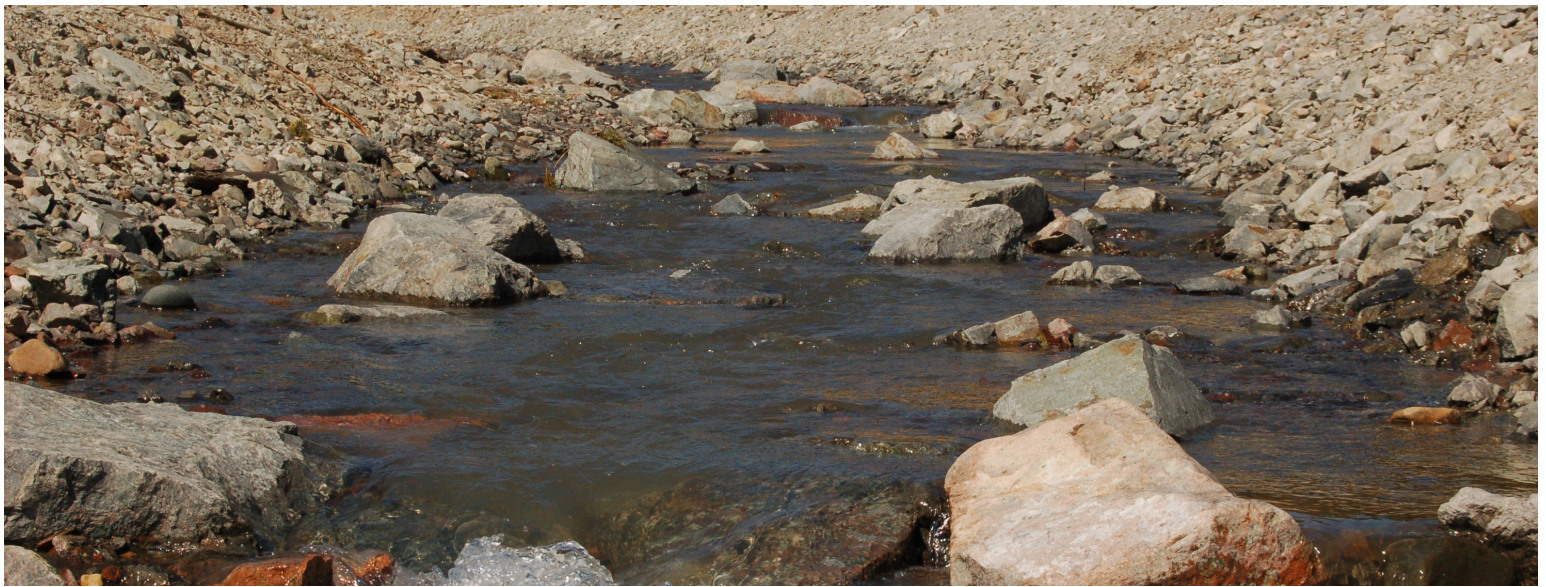
Lower Hazeltine Creek right after erosion control works in the channel had been completed. The water began to clear up quickly

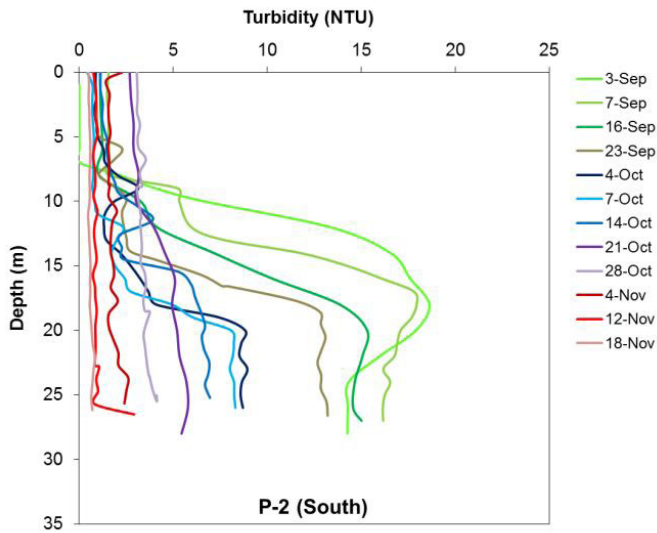
In mid-October, Polley Lake ‘turned over’ resulting in mixing of the shallow and deep water and the associated turbidity and lower dissolved oxygen. By mid-November, Polley Lake had recovered with turbidity and dissolved oxygen concentrations back to pre-event conditions. The potential biological impact of these changed conditions immediately following the dam failure is discussed further below, but the miners on site doing the restoration work during the spring reported that a population of rainbow trout vigorously entering the Fry Pan Creek to spawn. The rainbow trout were blocked from spawning in Hazeltine Creek which was undergoing

Figure 14: Post-event turbidity measurements with depth in Polley Lake showing the turbid water at depths of greater than 7 m below the surface

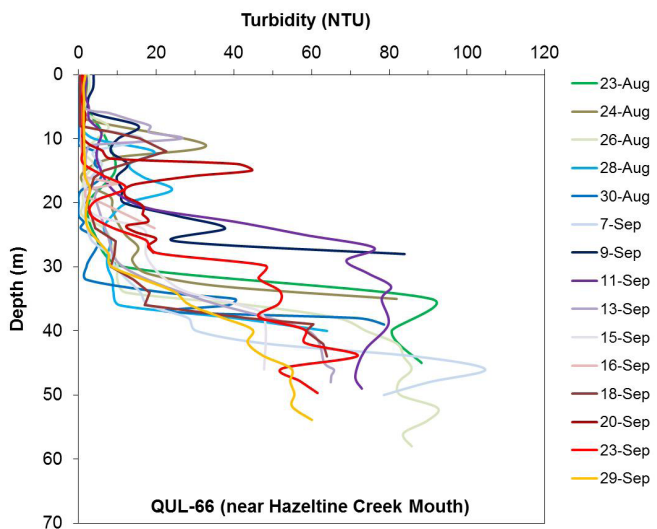
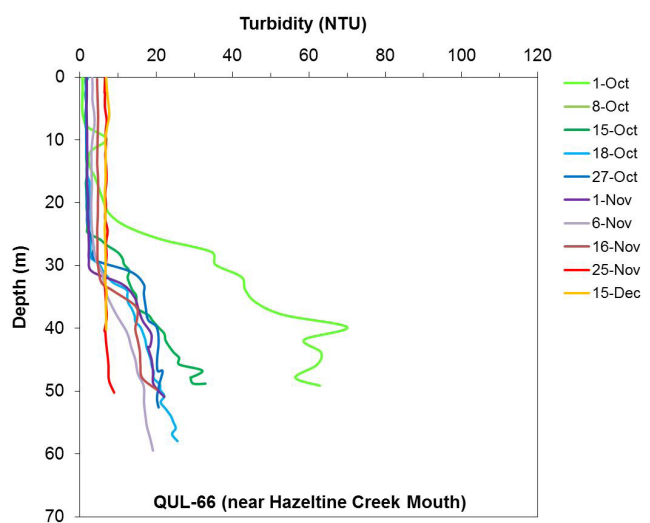
A similar chain of events occurred in Quesnel Lake, except the lake ‘turn over’ event occurred in mid-November. The mixture of displaced material that entered Quesnel Lake following the dam failure was more dense (“heavier”) than Quesnel Lake water and so caused turbid water at depths ranging from 10 to 25 m and beyond (Figure 15).

Figure 15: Turbidity measurements in Quesnel Lake near Hazeltime Creek over time. The results show the higher turbidity measurements with depth.

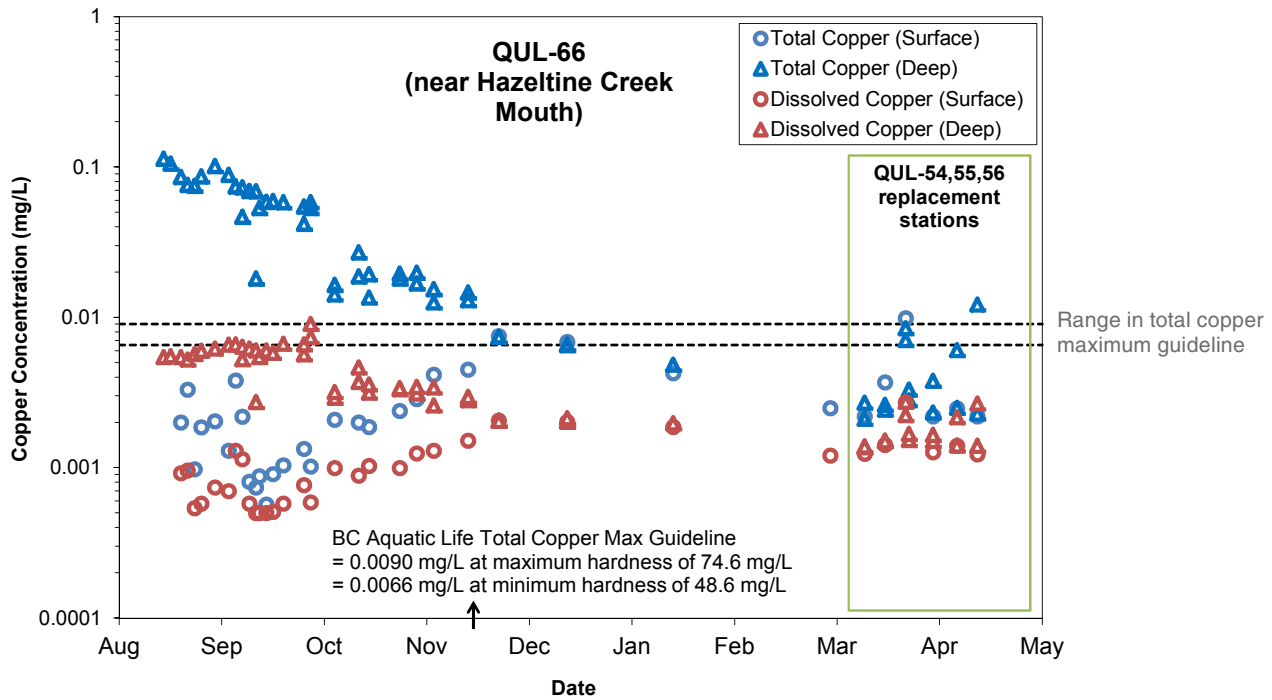
Figure 16: Post-event measurements of total and dissolved copper in Quesnel Lake near Hazelline Creek

With the increase in turbidity at depth, there was an associated increase in the concentrations of total copper at depth. The concentrations of total copper were above the BC Water Quality Maximum Guideline between August and November of 2014, and were generally below the guideline since then (Figure 16). The concentrations of dissolved copper were below the water quality guideline even at depth where the turbid water was located, providing confirmation of the geochemistry results that found the copper in the tailings soil mixture was not leachable.

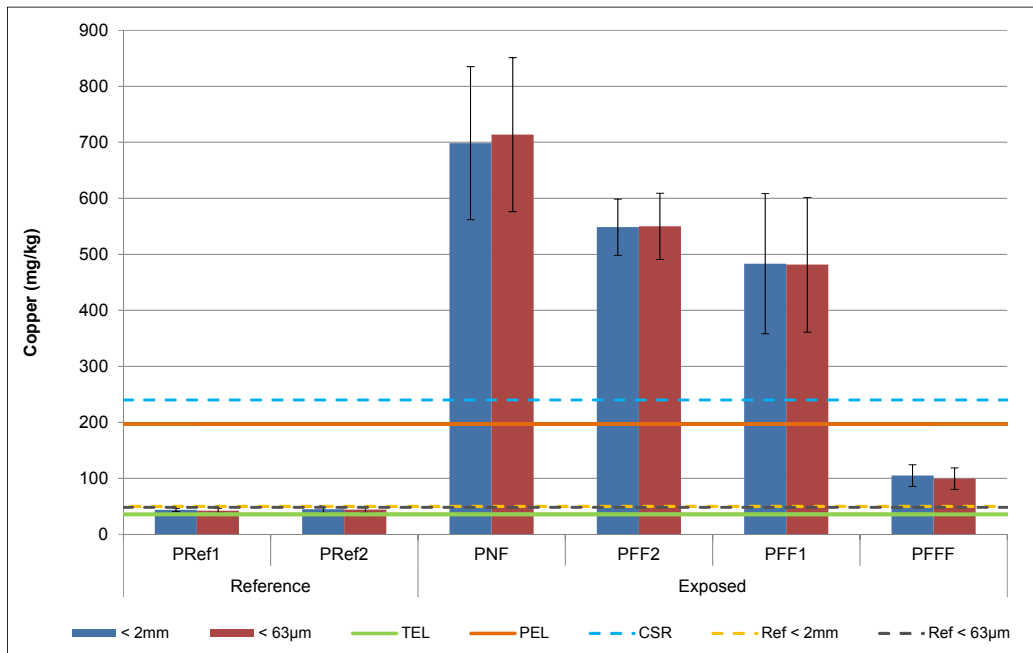
As expected, the sediment locations closest to the dam failure had higher concentrations of copper than samples taken more distant from the TSF. Sediments in Quesnel Lake near Hazeltine Creek had concentrations of copper (Figure 17) that exceeded the provincial sediment quality guidelines and are higher than background concentrations. Consistent with the findings of the soil quality assessment, the sediments also exhibited low nutrient content and low concentrations of organic carbon content. Several studies conducted in collaboration with the geochemical assessment indicated low potential for bioavailability of metals (including copper) to benthic-dwelling organisms in the lakes and river. Therefore, although copper concentrations in sediment exceed provincial guidelines, the copper and other associated metals are not expected to be harmful.

Figure 17: Mean copper concentrations ($\pm 1*SE$) in sediment from profundal sampling areas in Quesnel Lake, Mount Polley Mine, 2014
