REPORT

Remediation Plan

Mount Polley Mine Perimeter Embankment Breach

1894924-076-R-Rev0-23197

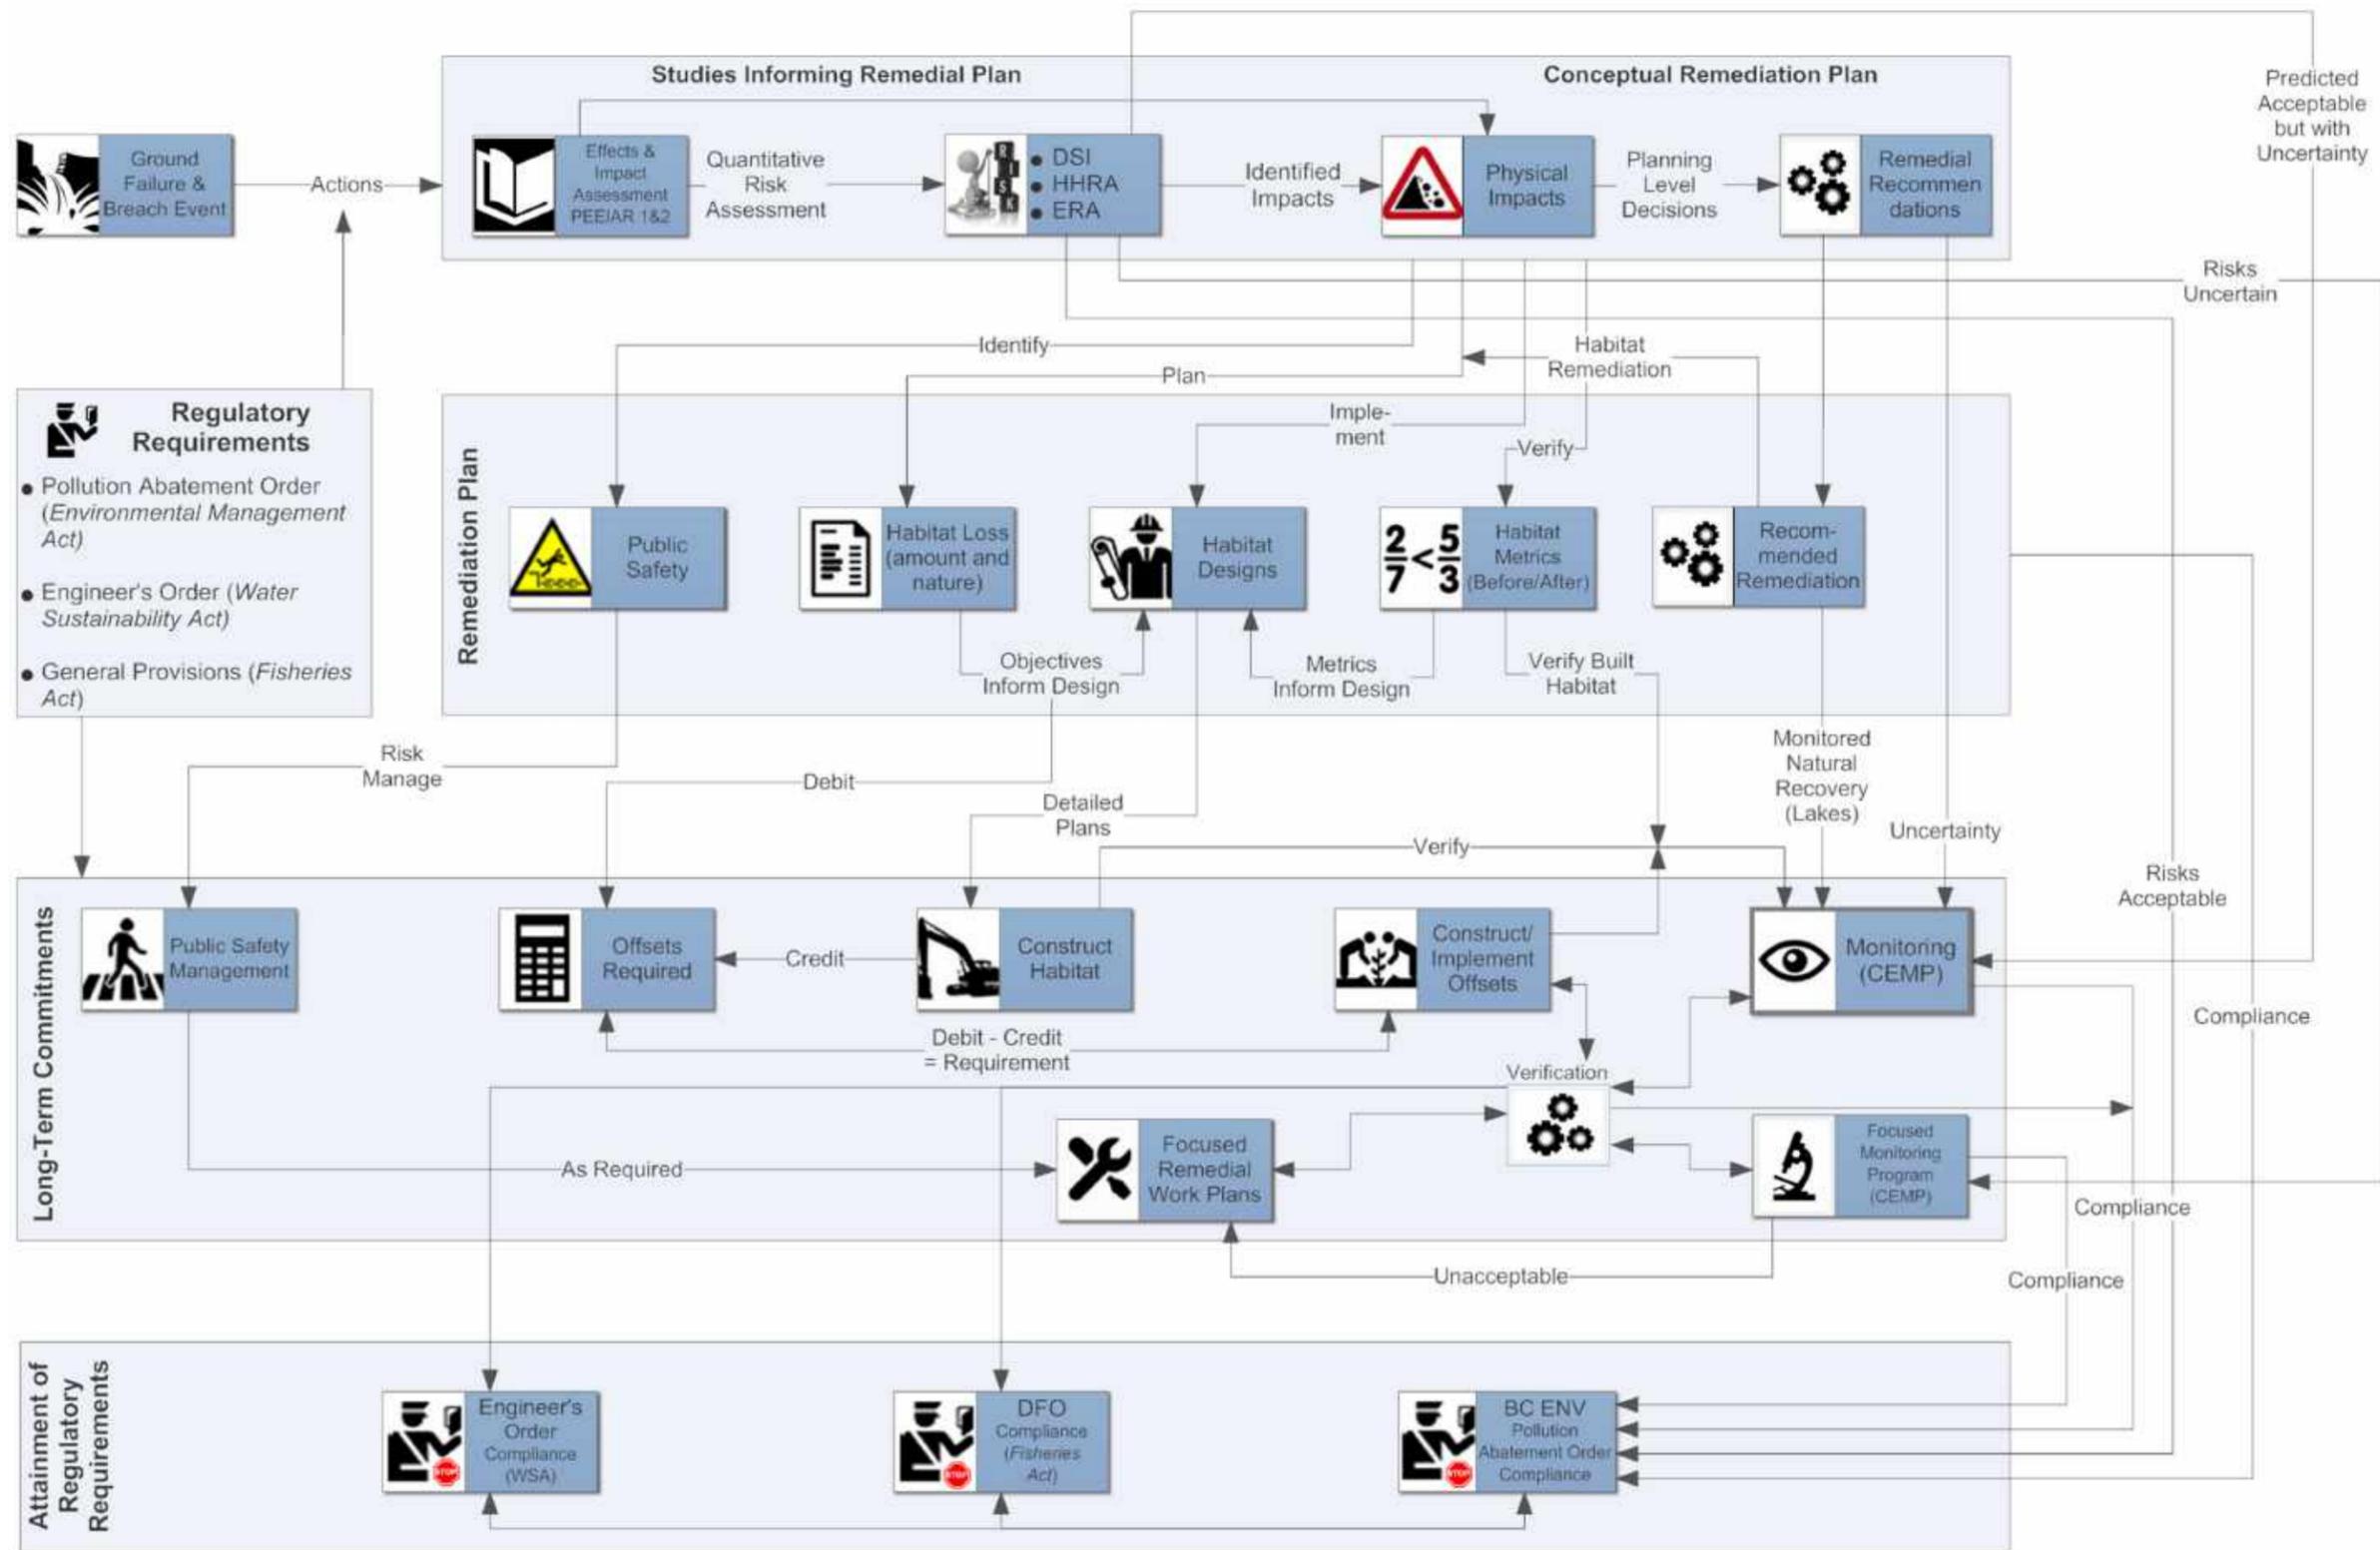
Figure ES-1: Diagrammatic Representation of Remediation Plan Component Linkages

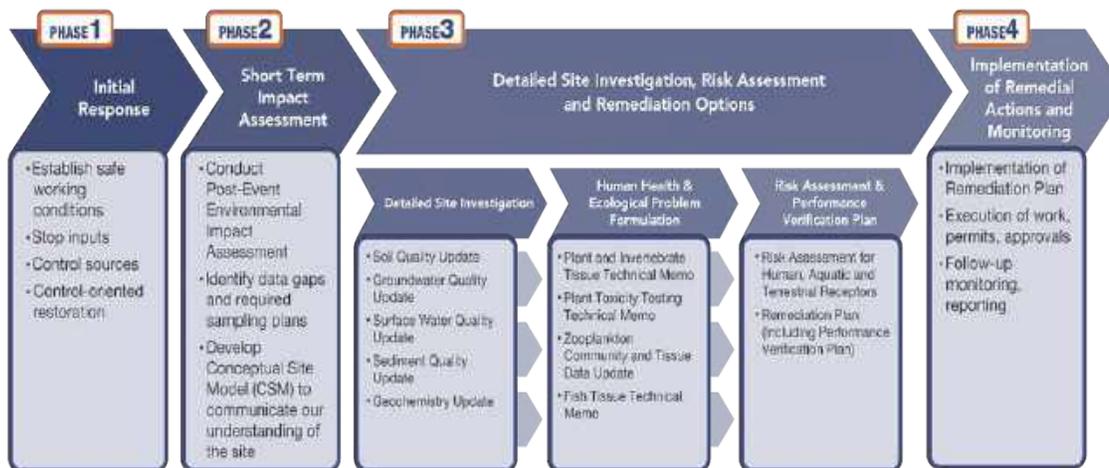
Figure 2: Mount Polley Tailings Storage Facility Breach Response Remediation Framework (this report represents the last element in Phase 3)

The original framework for the TSF breach response framework consists of four main phases (Figure 2) and nine identified remediation areas (Figure 1) that break up the breach-impacted areas into smaller management units. Ideally, the remediation framework phases are presented sequentially with the information generated or decisions made in one phase feeding into the planning, actions or definition of information needs for a subsequent phase. However, given the dynamic nature of the response and the environmental and regulatory conditions under which it was implemented, some of the actions required adaptive sequencing, but are nevertheless consistent with the intent of the framework (see for example Nikl et al. 2016). Some changes to the framework have occurred during implementation; for instance, the performance verification plan was replaced by the Comprehensive Environmental Monitoring Plan (CEMP).

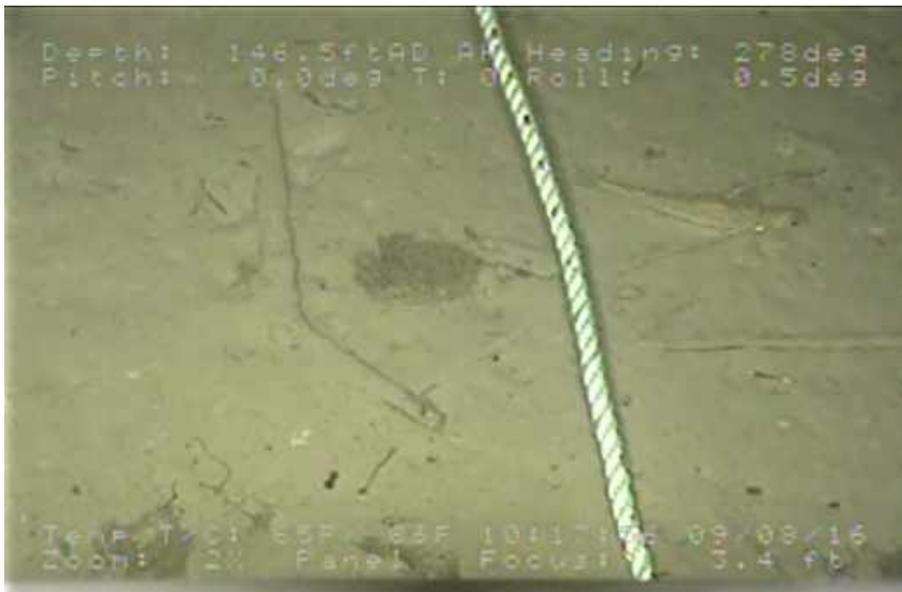
Figure 5: Image extracted from an ROV video (coincident observations, not a quantitative fish survey) recorded during an outfall inspection, showing that the lakebed is being used by fish in Quesnel Lake, near the outlet of Hazeltine Creek (fish is in the upper right quadrant of the image, the rope was temporarily placed to set the course for the ROV).

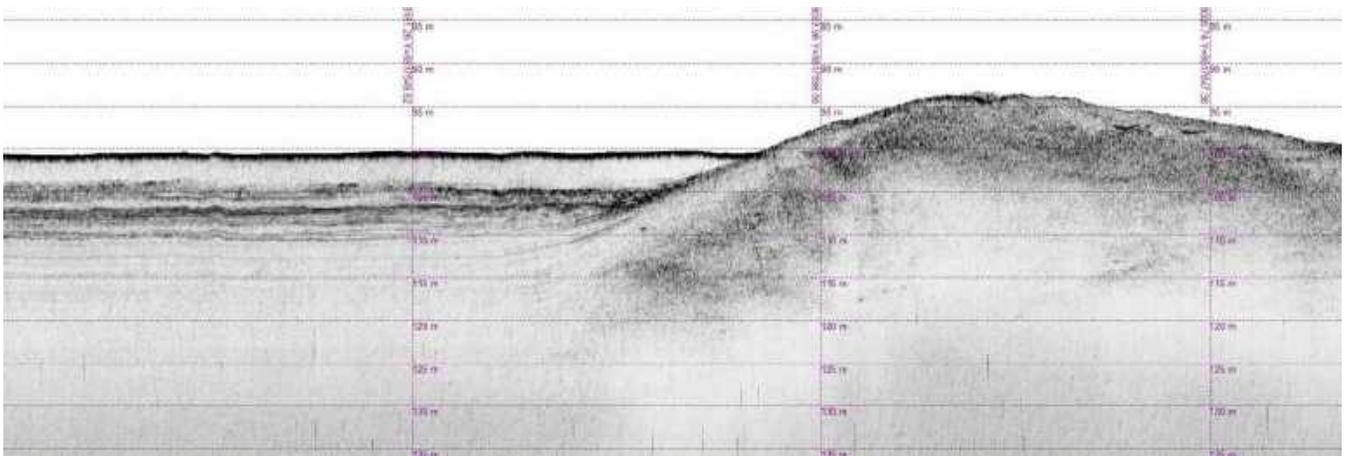
Figure 6: A sub-bottom profile image of a section of Quesnel Lake showing fine-grained sediments settled along a flat section (left of image) and an underwater lake side slope along the rise on the right half of the image.

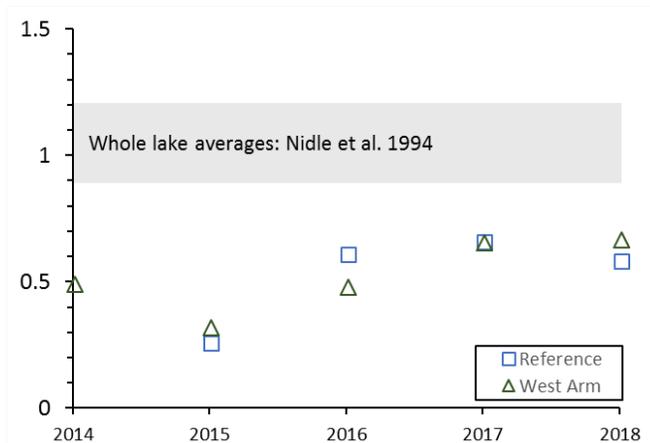
Figure 7: A comparison of pre-mining (1985-1990) chlorophyll a whole lake averages (grey band) concentrations and post-breach chlorophyll a concentrations in the West Arm and reference area.

A comparison of whole lake averages over the period for which pre-impact data are available (1985 to 1990) with chlorophyll *a* concentrations in the years following the breach indicates that the algal biomass of Quesnel Lake may have been higher prior to mining at Mount Polley than has been the case following the breach. This suggests that the conditions favouring algal growth are not higher post-breach.

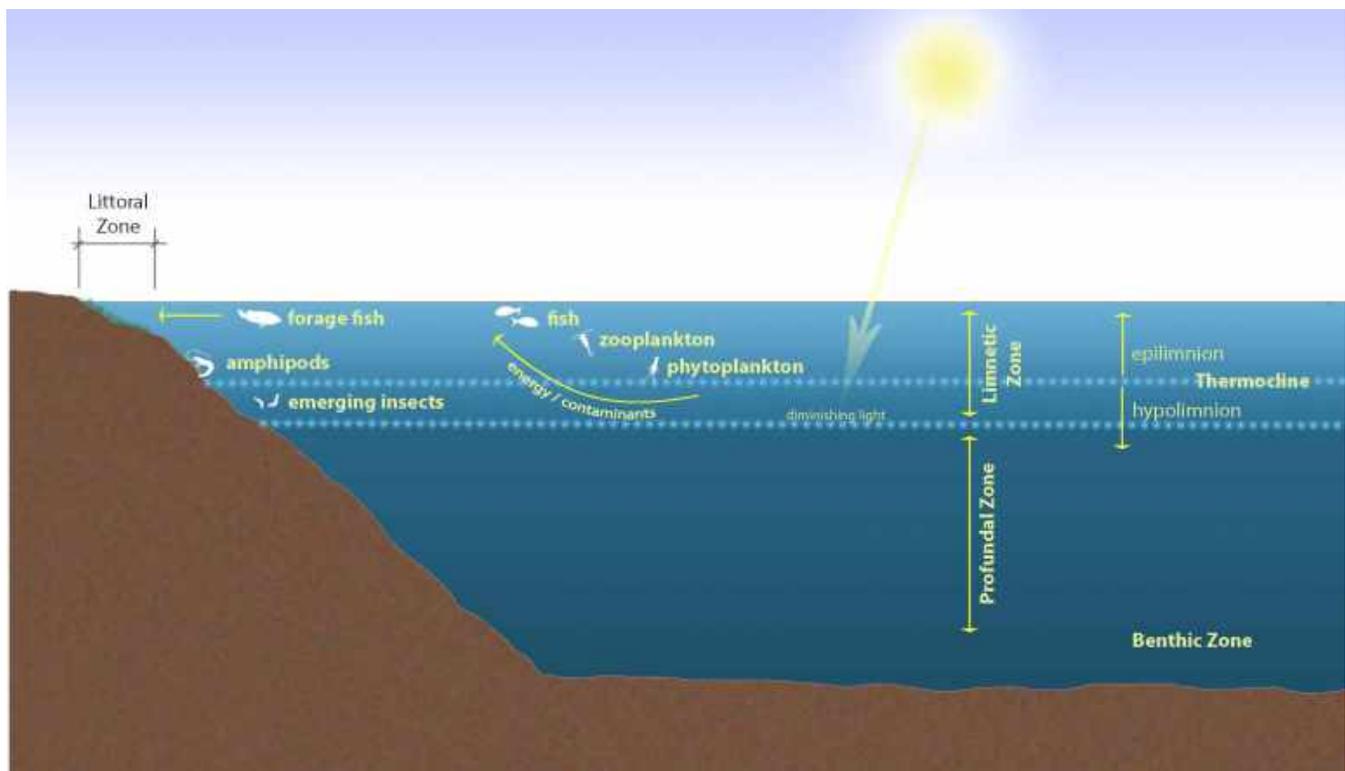
Figure 9: Generalized Conceptual Ecological Model for a Lake

- Hypolimnion – the water column below the thermocline.
- Limnetic zone – the portion of the water column through which light penetrates.
- Littoral zone – the area of the lakeshore where aquatic plants grow. In Quesnel Lake, this area is variable but approximately 4 to 6 m deep.
- Phytoplankton – free-floating plants/algae and photosynthetic bacteria.
- Profundal zone – the portion of the water column that light does not reach and as a result does not support plant growth. Elsewhere in this report, this may also be referred to as the “benthic” zone.
- Thermocline – a sharp density gradient in the water column that limits mixing of the water column which is caused by differences in temperature between the upper and lower water column. In the summer, the surface of the water column is warmer and the water at depth is cooler.
- Zooplankton – free-floating invertebrates.

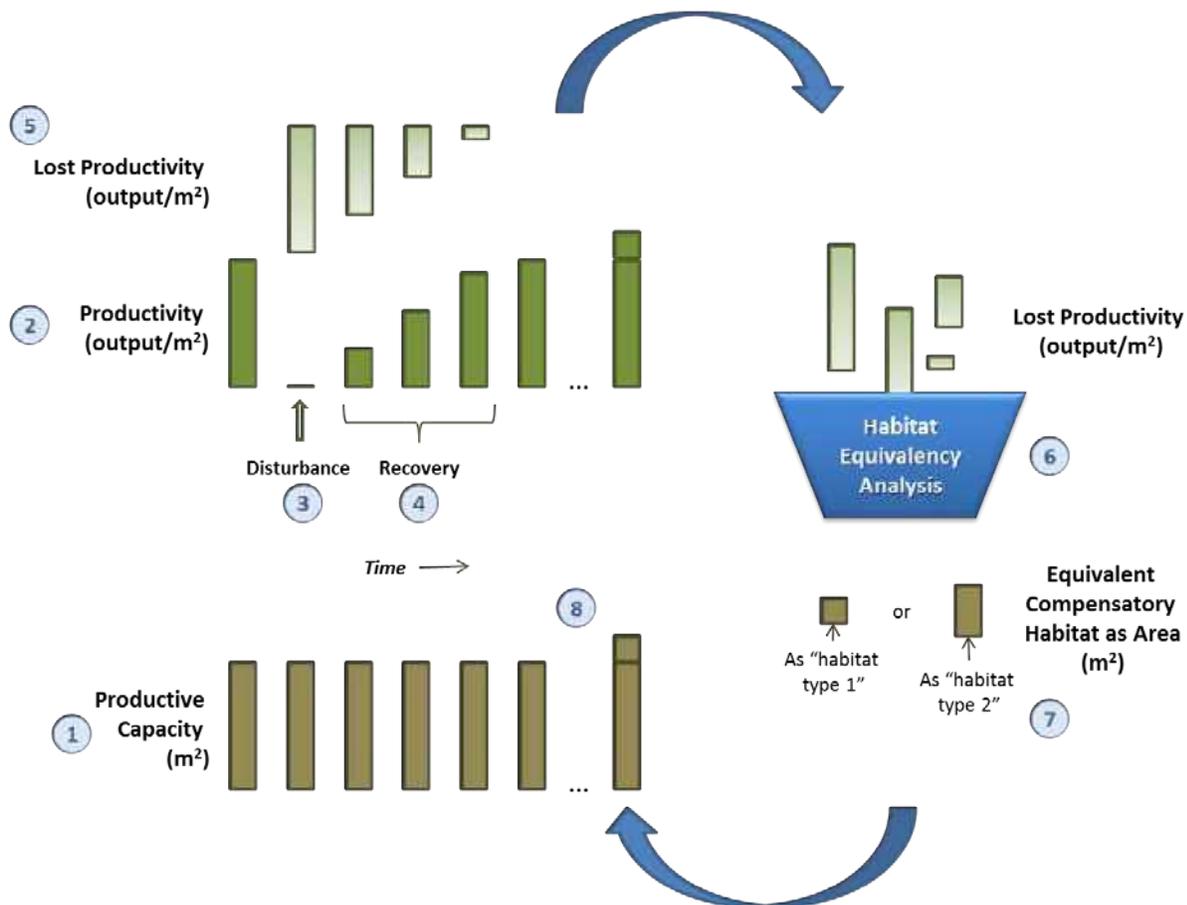
Figure 10: Illustration of Habitat Equivalency Analysis Concept

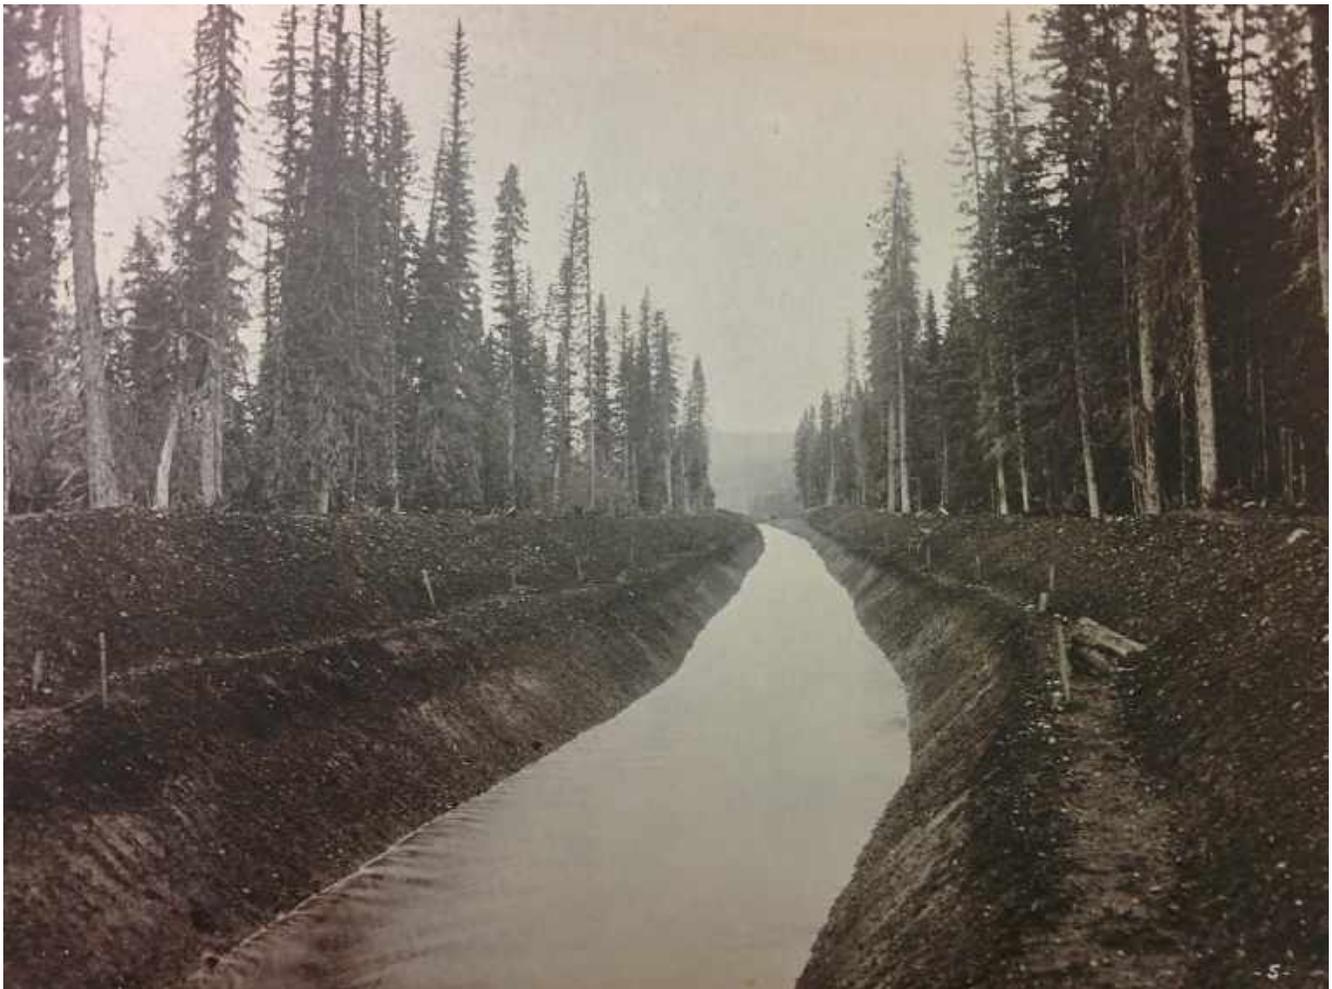
Figure 11: Historic Photo of Polley Lake Cut for Hydraulic Mining (CCHMC, undated, ca. 1900)

Using the classification system of the HRWG, this area corresponds to Ecological Unit H1. Polley Flats / Reach 1 represents the outlet channel of Polley Lake and encompasses approximately 70 ha of the TSF breach area. The natural stream alignment flowing out of Polley Lake had been historically (late 1800s to early 1900s) directed into a manmade, diversion channel for the first 775 m (Golder 2015b) as part of the water supply for hydraulic mining in the area (Figure 11). This channelized outlet ran along the east side of what was historically a vegetated, meandering flood plain. The pre-breach channel connected with a beaver pond which also received input from Bootjack Creek. Polley Flats and Area 2 extended a short distance (~300 m) past this stream convergence, part way into Reach 2 where the stream channel became better defined but still incorporated some beaver dam ponds and side channel meanders (Golder 2015b).

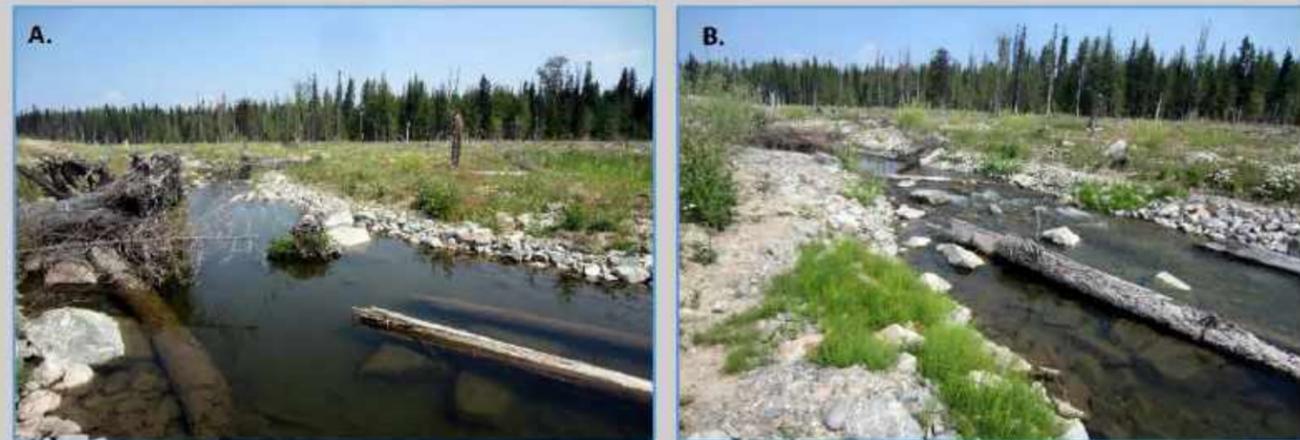
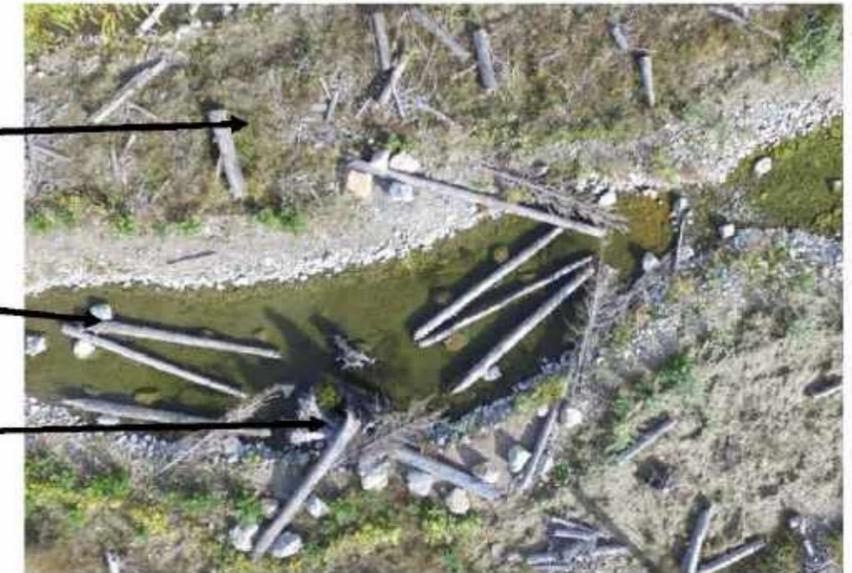
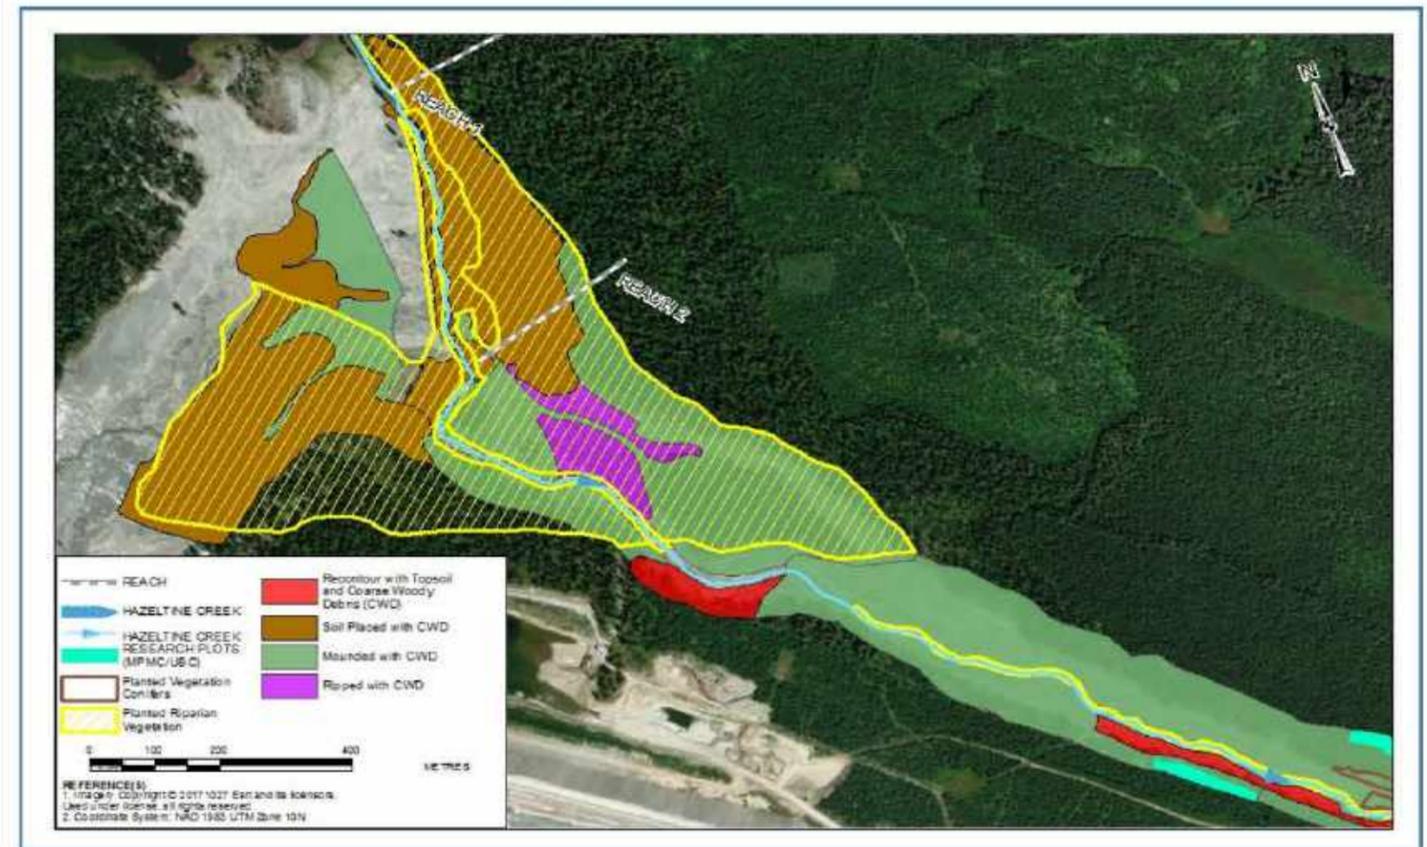
Woody debris scattered throughout riparian zone

Tree tops for instream and overstream cover

Figure 12: Polley Flats / Area 2 (Reach 1) Description and Current Remediation and Rehabilitation Status

Terrestrial remediation efforts are ongoing with a focus on site preparation and planting. Mounding and ripping as a site preparation method, has helped alleviate compaction and helped liberate the original topsoil over 14.5 ha (20%) of Area 2. This site preparation also creates atmospheric connectivity which increases oxygen exchange and promotes soil fauna and microbial communities. Additional site preparation methods include placing imported soil over 19 ha to bring in needed nutrients and improve growing medium structure. Woody debris has been placed over all the site preparation areas to promote structural heterogeneity and to provide microsites for establishing plants. Remediation efforts such as these, improve the physical and structural properties of the soil, and facilitate re-establishment of vegetation. Upland and riparian plantings have been initiated over 35.6 ha (50%) of the disturbance zone in Area 2.

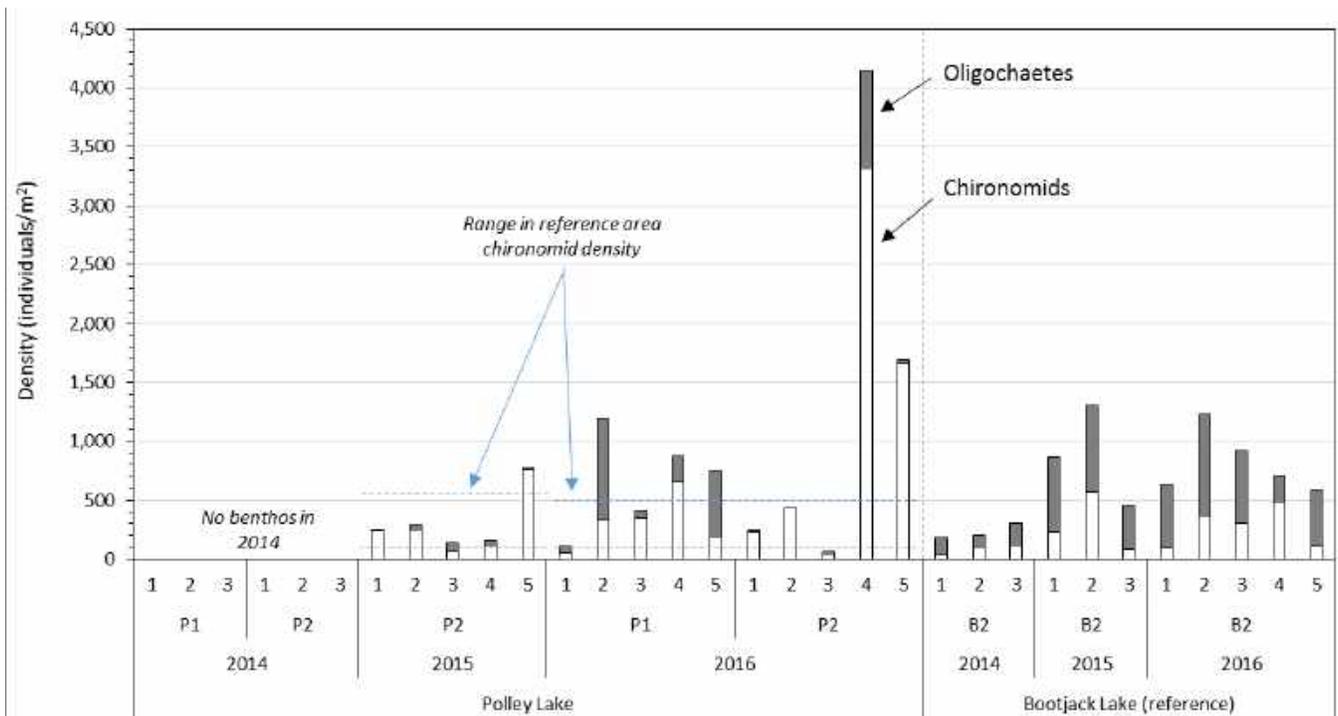
Note: Bars show individual replicates. Source of data: Golder (2017c).

Figure 13: Spatial and Temporal Variability in Benthic Invertebrate Density in Polley Lake Deep Areas, 2014, 2015, and 2016

Figure 13 shows the density of chironomids and oligochaetes in deep areas of the lake and Figure 14 shows the density in mid-depth areas of the lake in Polley Lake and in the reference area, Bootjack Lake, for 2014, 2015, and 2016. No benthic invertebrates were found in the deep area of Polley Lake in 2014 and in the mid-depth zone, the numbers were lower than found in Bootjack Lake. In the year after the breach, the deep benthic community was recolonizing the substrate and chironomid density in all but two replicates was within the range observed in reference Bootjack Lake. By 2016, the mid-depth benthic community had a higher density than that of Bootjack Lake (Figure 14). Subsequent sampling of Polley Lake has not been undertaken.

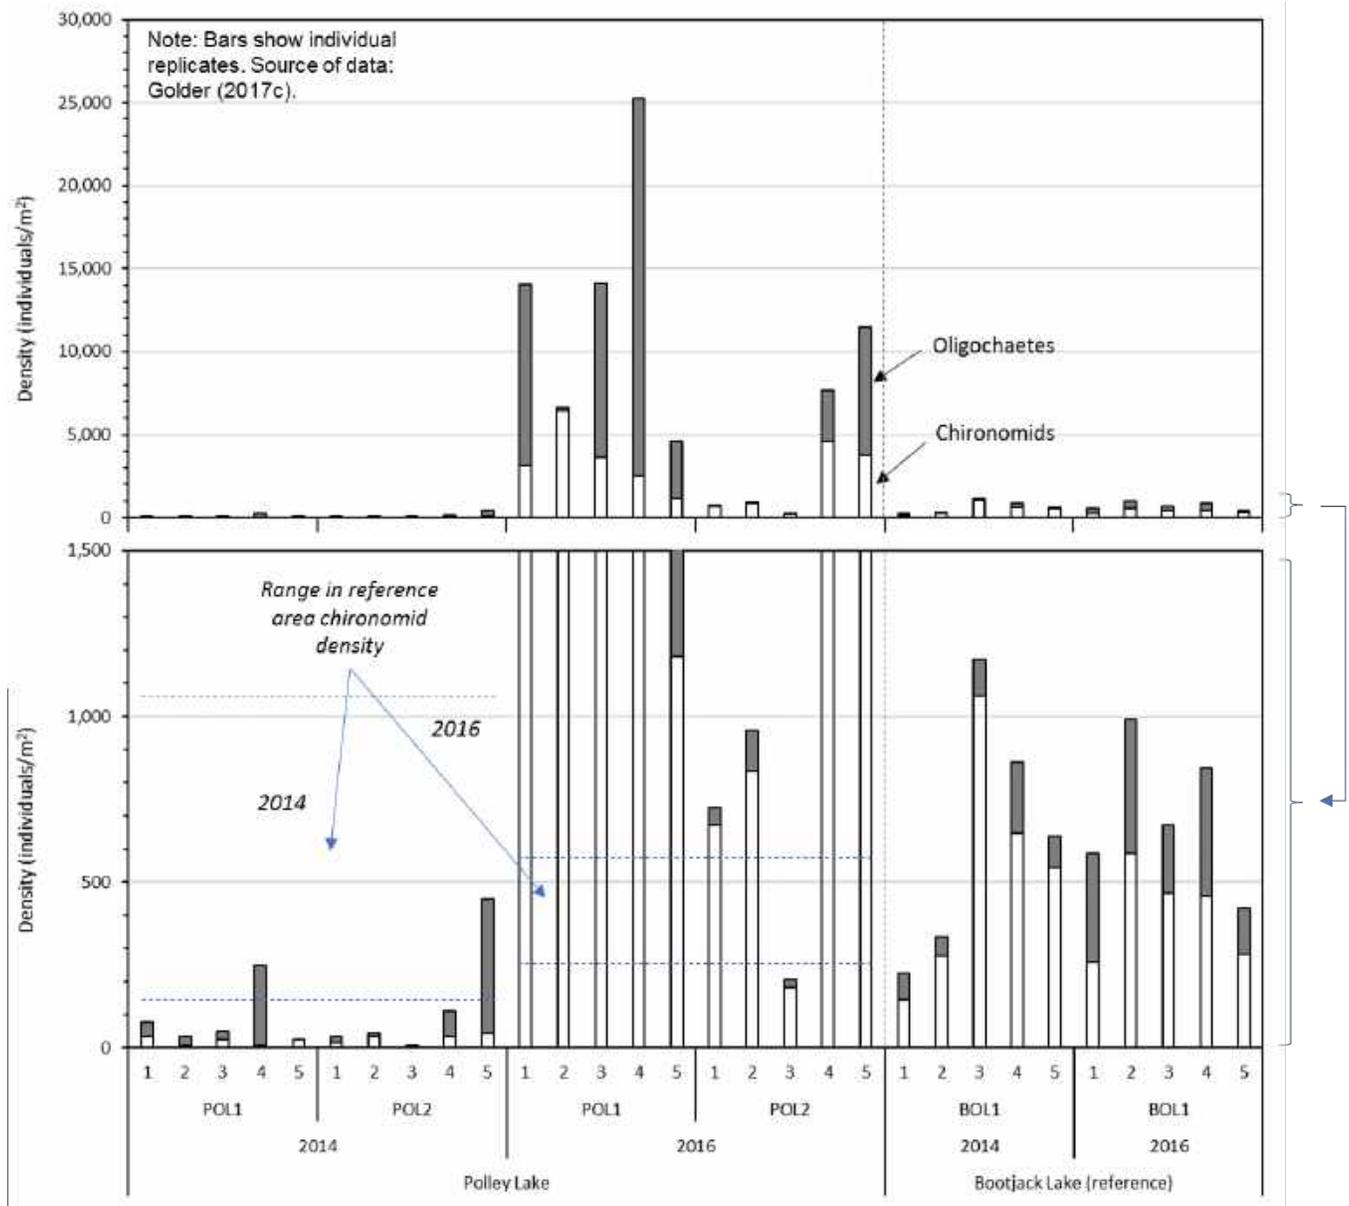
Figure 14: Spatial and Temporal Variability in Benthic Invertebrate Density in Polley Lake Mid-depth Areas, 2014 and 2016

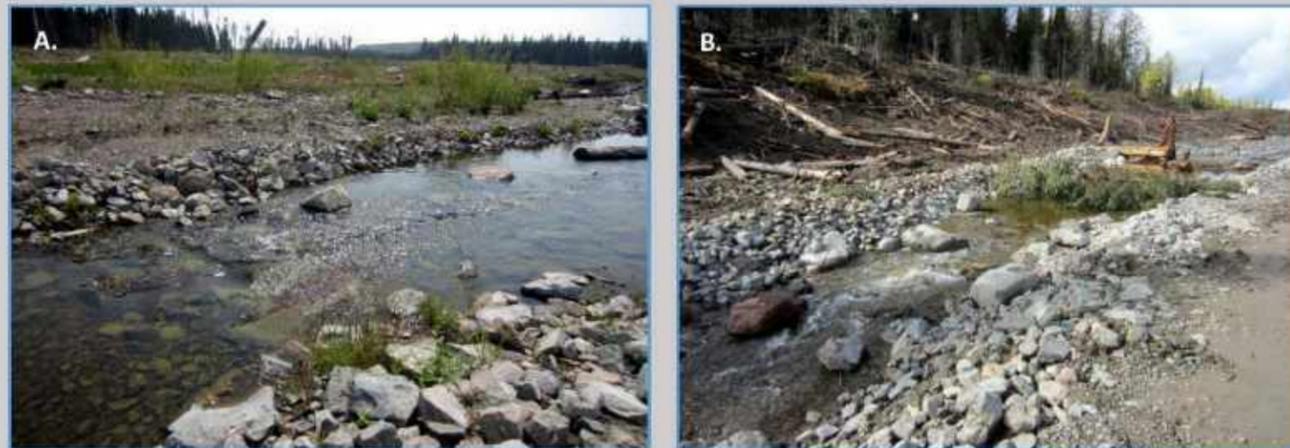
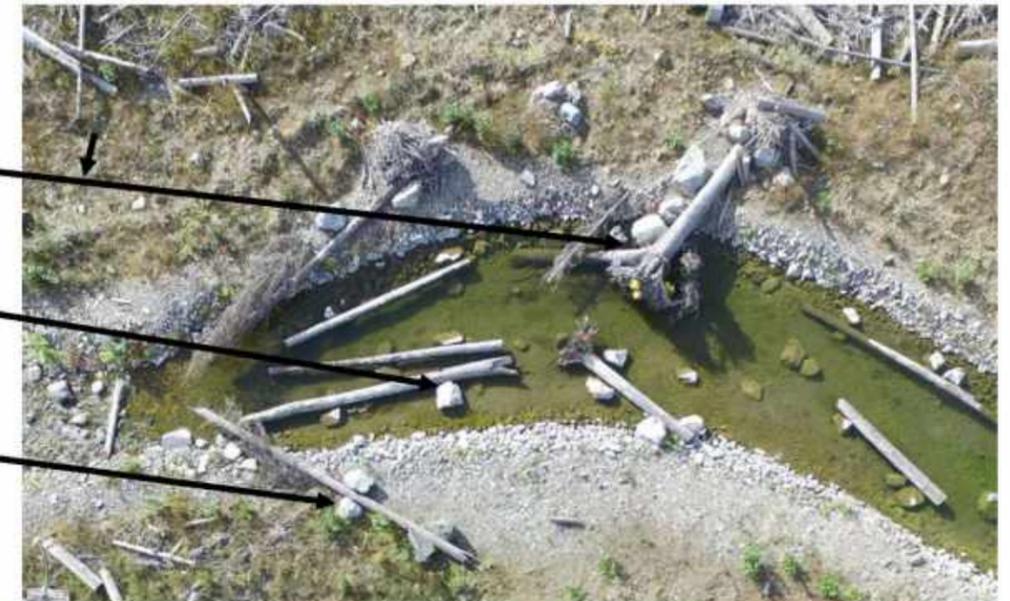
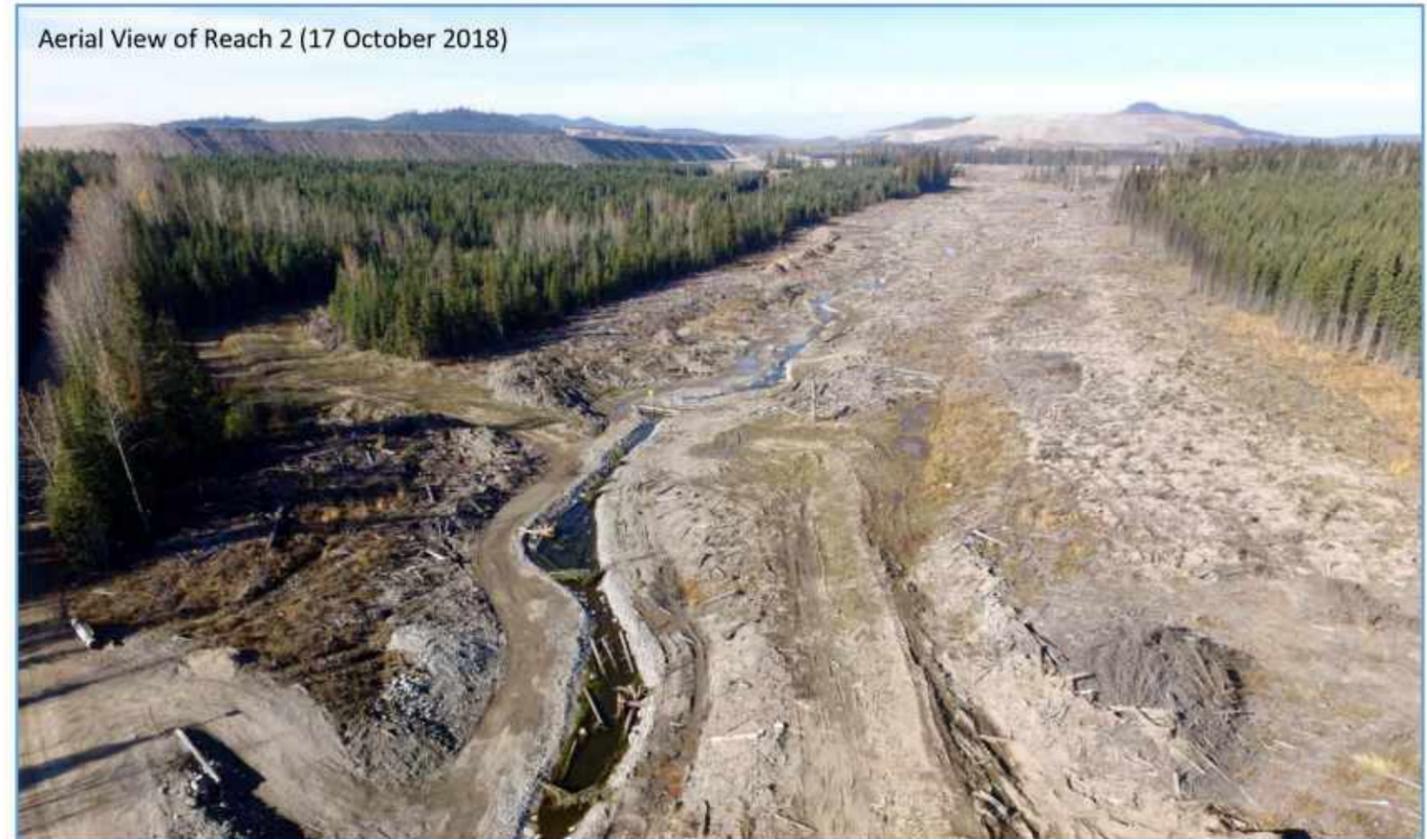
Typical status of Reach 2 channel on 31 July 2018 (A) and Reach 3 channel on 17 September 2018 (B)

Aerial View of Reach 2 (17 October 2018)

Figure 15: Reach 2 and 3, Upper Hazeltine Creek (Area 4) Description and Current Remediation and Rehabilitation Status

Terrestrial objectives in Reach 2 and 3 include improving soil conditions and reducing long term sediment load into Hazeltine Creek, as well as improving structure and function of habitat by introducing coarse woody debris and surface roughness via mounding and ripping. Revegetation efforts to date consist of grass seeding with an erosion mix and allowing natural ingress from nearby seed sources. The establishment of shrubs and deciduous trees mature is expected to be gradual and be replaced by dense stands of conifers. Channel conditions should continue to evolve into productive trout habitat with nutrient inputs from the surrounding vegetation.

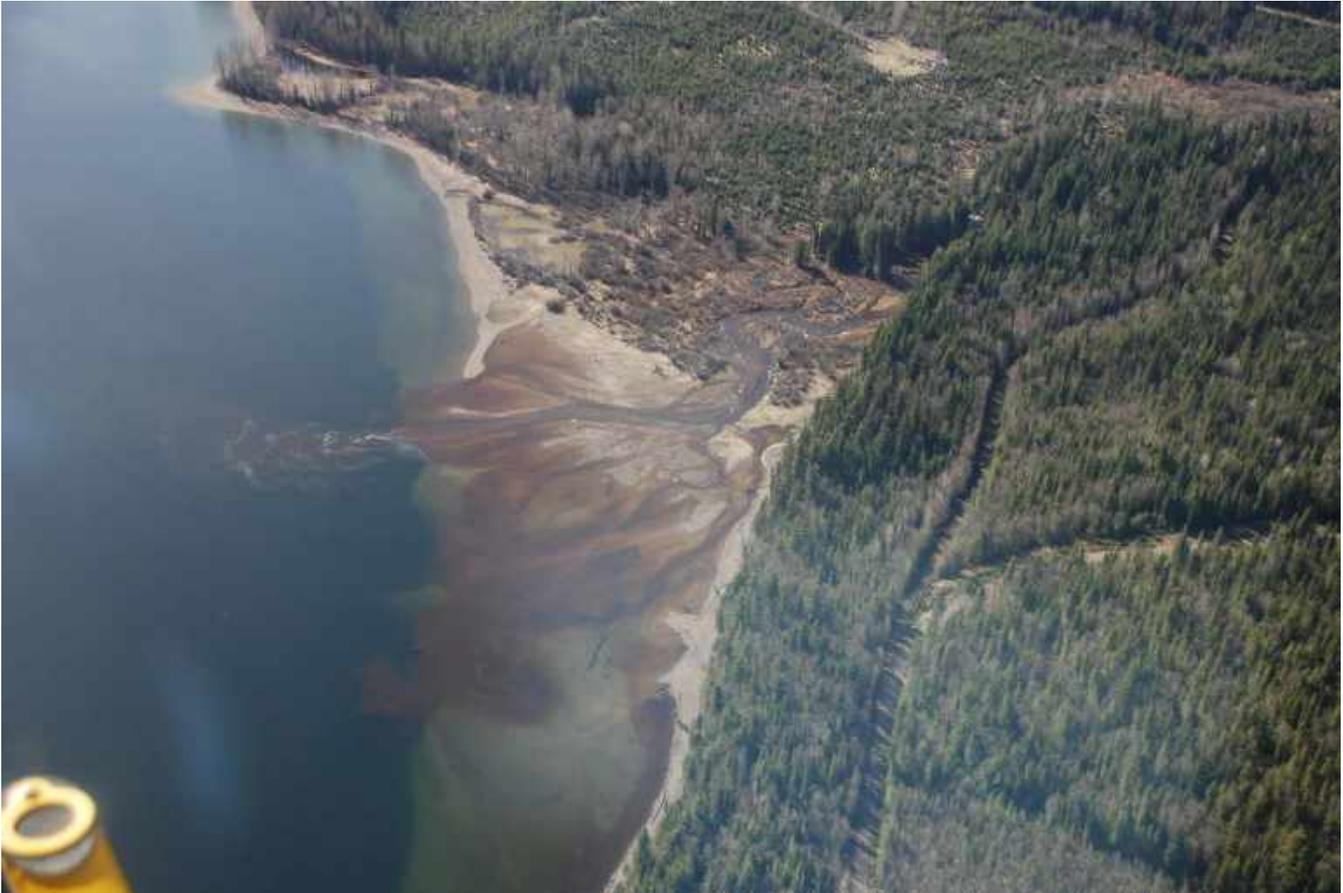
Figure 16: A 2008 Photo of the mouth of Hazeltine and Edney Creeks. Prior to the breach, these streams were combined in a single channel. (Photo Courtesy MPMC).

The primary aquatic objective for Reach 5 (Area 6a) is to provide both rearing and spawning habitat for Sockeye salmon Rainbow Trout and Coho salmon. The overall channel remediation of Hazeltine Creek includes the lower floodplain, the Mean Annual Flow (MAF) channel, and the low flow channel. The primary meander pattern is exhibited by the lower floodplain; this part of the overall floodplain is engaged by flows associated with freshet. Armouring was undertaken to minimize erosion of the materials underlying the channel. Pockets of tailings and breach outwash materials were removed from the footprint of the constructed channel and from the footprint of any fill materials placed in the floodplain. Flow velocities in Reach 5 are conducive to spawning by both rainbow trout and Coho salmon. Grades were deeply incised by the release event and cuts into adjacent slopes to achieve relatively elaborate meanders were minimized as this would exacerbate existing cuts, resulting in further impacts to treed woodlands.

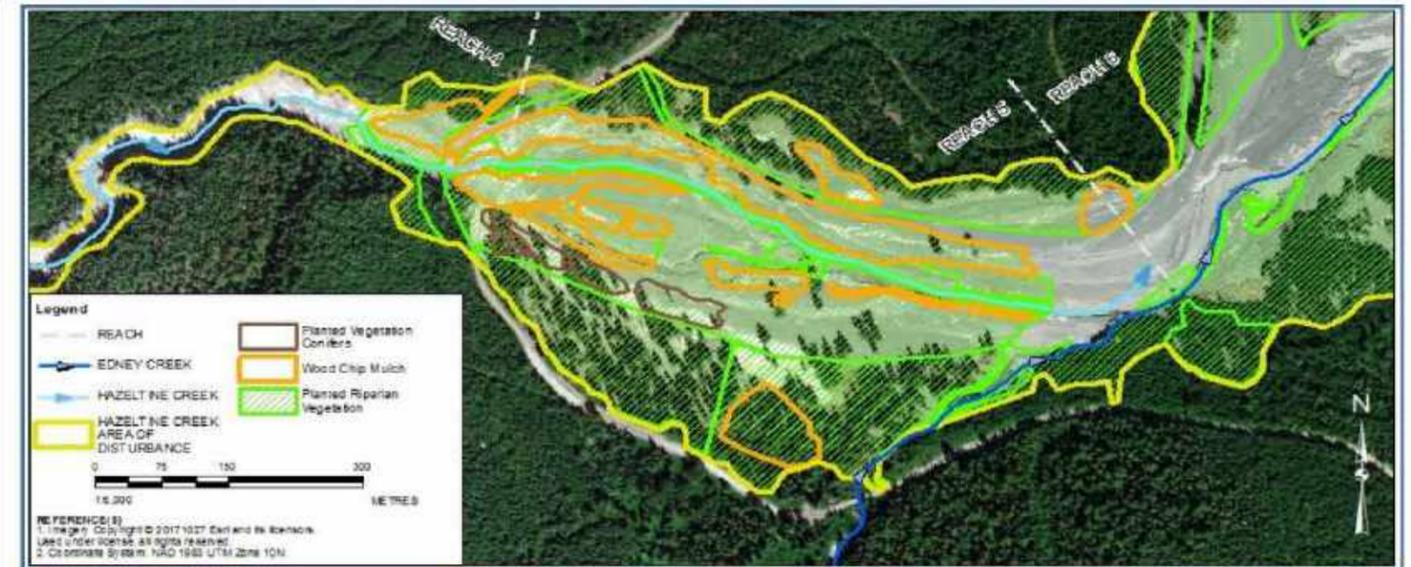
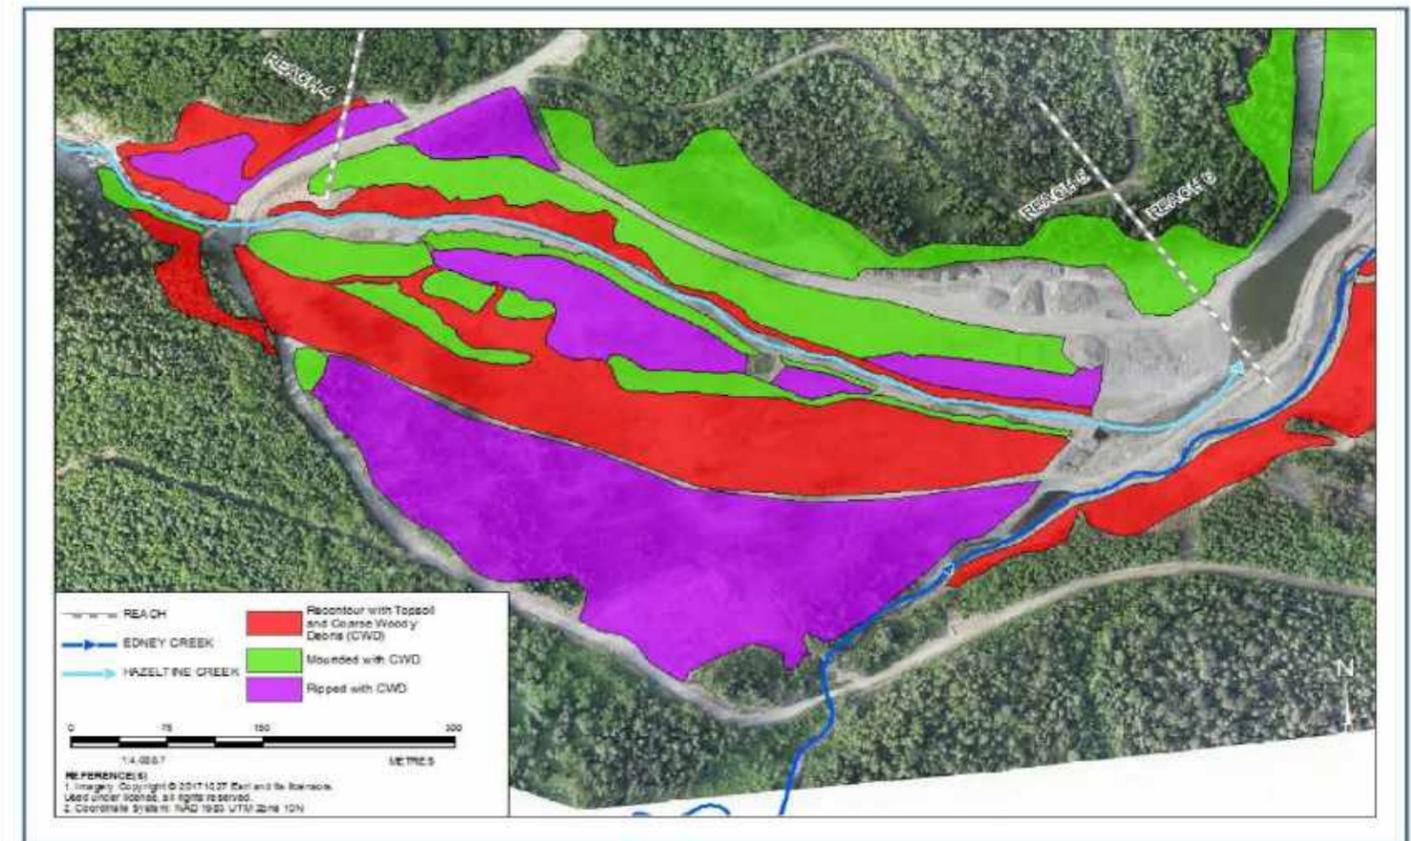
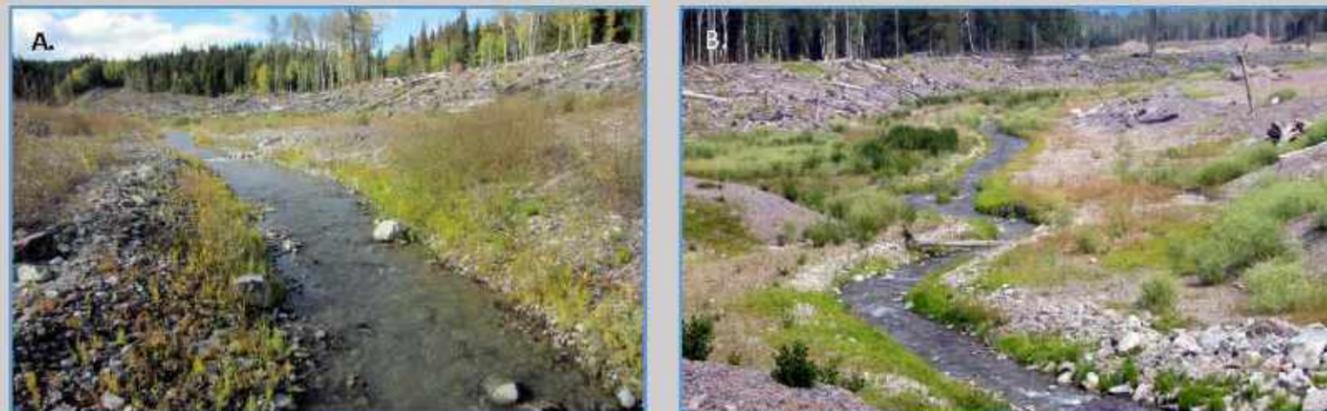
Reach 5 on 17 September 2018 (A) and 31 July 2018 (B)

The remainder of Reach 5 will be complexed with boulders, logs and tree tops to provide instream and overstream cover for fish. The interaction of flows with these features will sustain and/or create runs, small riffles and small ponds along the design alignment of the low flow channel and will facilitate mixing throughout the water column of the ponds. The features will enhance turbulence, important in creating hydraulic refugia for both adult and juvenile fish. It is this complexity that will sustain rearing habitat for juvenile trout. To date, soil rehabilitation efforts have reduced long-term sediment load flow into Hazeltine Creek by removing tailings and increased oxygen exchange with native soil. Ripping and mounding, along with Coarse Woody Debris (CWD) placement, have created micro sites that foster regenerating plants increase habitat complexity in this reach. Of the 29 ha in this area, 22 ha have been roughened and planted with riparian species while over 6 ha have been recontoured with imported soil and complexed with CWD. In addition, wood chip mulch has been spread over 5 ha to control erosion and reduce soil moisture loss.
