REPORT

Remediation Plan

Mount Polley Mine Perimeter Embankment Breach

1894924-076-R-Rev0-23197

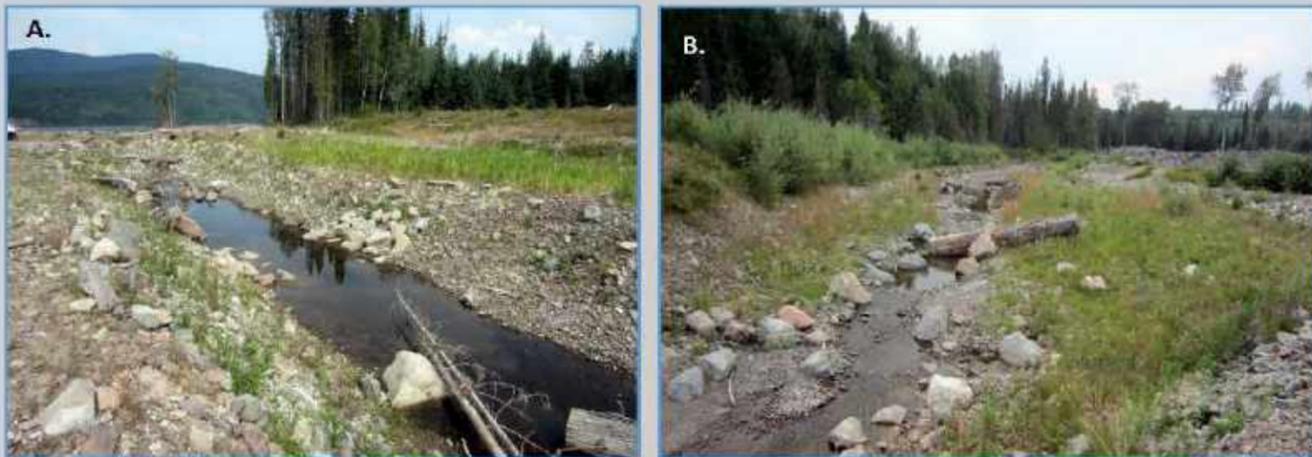
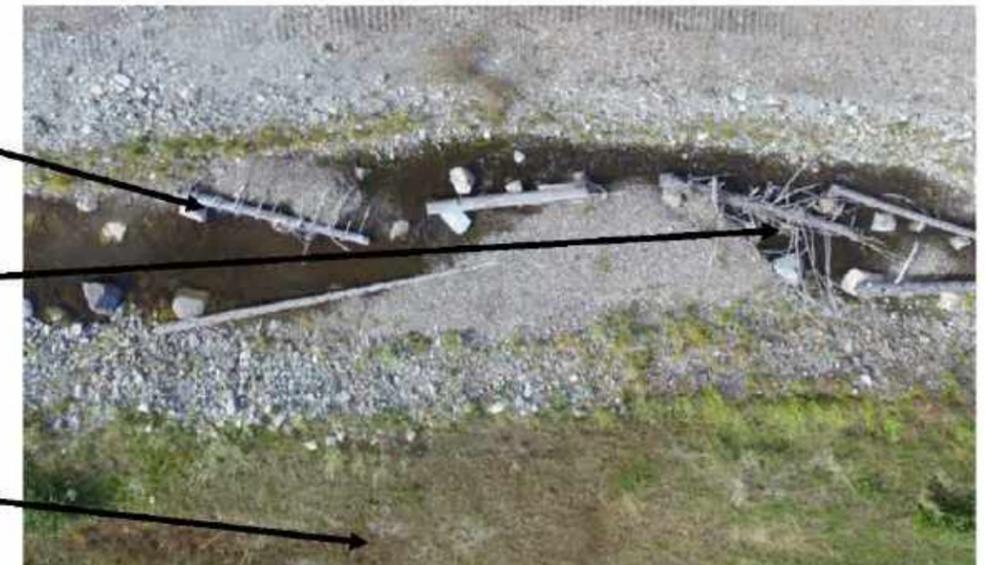
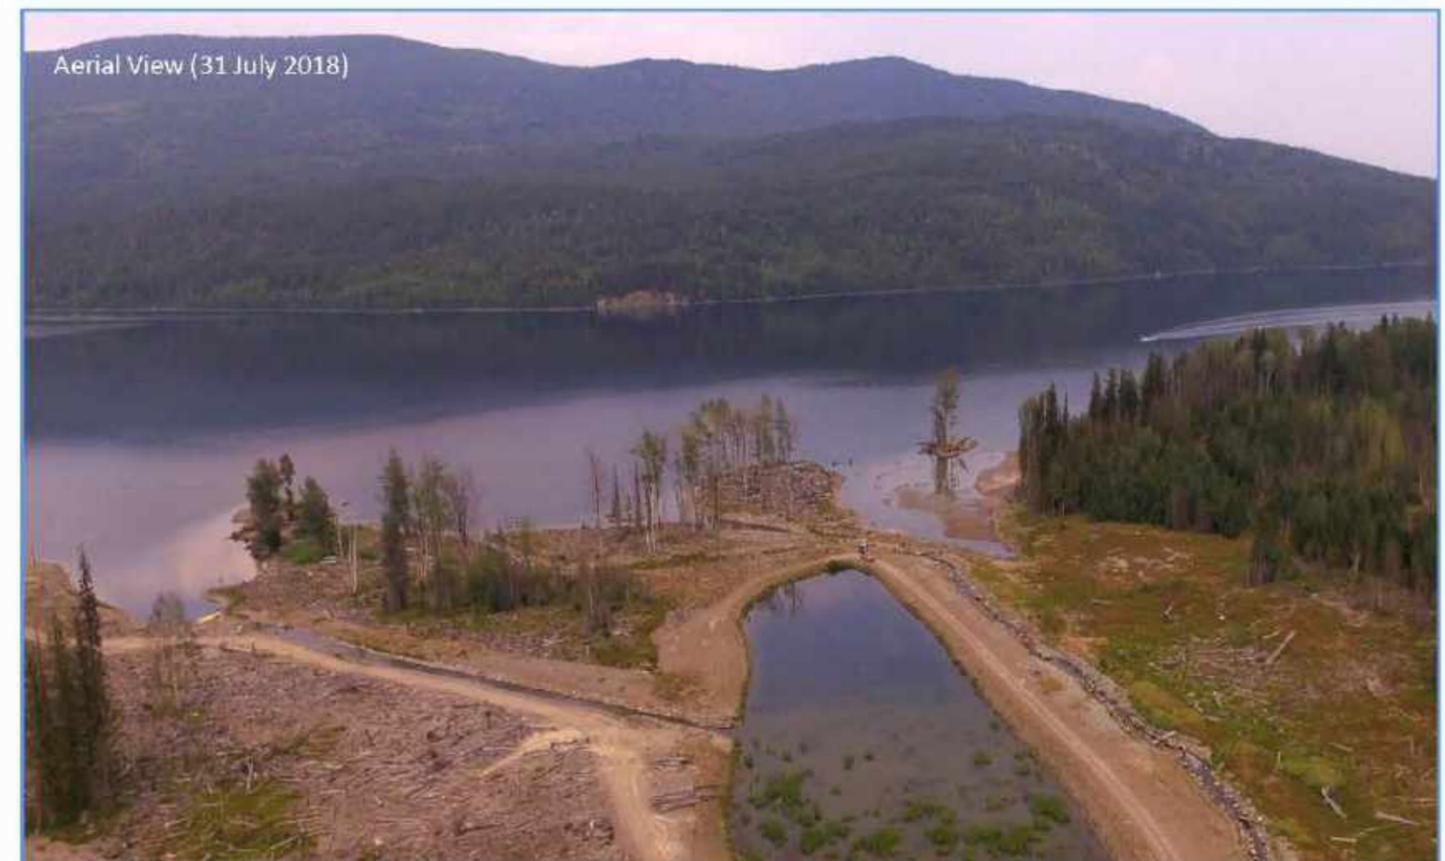
Reach 6 on 31 July 2018 (A and B)

Woody debris and riparian planting

Figure 18: Lower Edney Creek /Area 6b (Reach 6) Description and Current Remediation and Rehabilitation Status

In 2018, a tree planting program for ongoing revegetation include live staking with willow and poplar in riparian areas to assist ingress of conifer seedlings and establish an erosion control grass cover in the upper floodplain was put down.

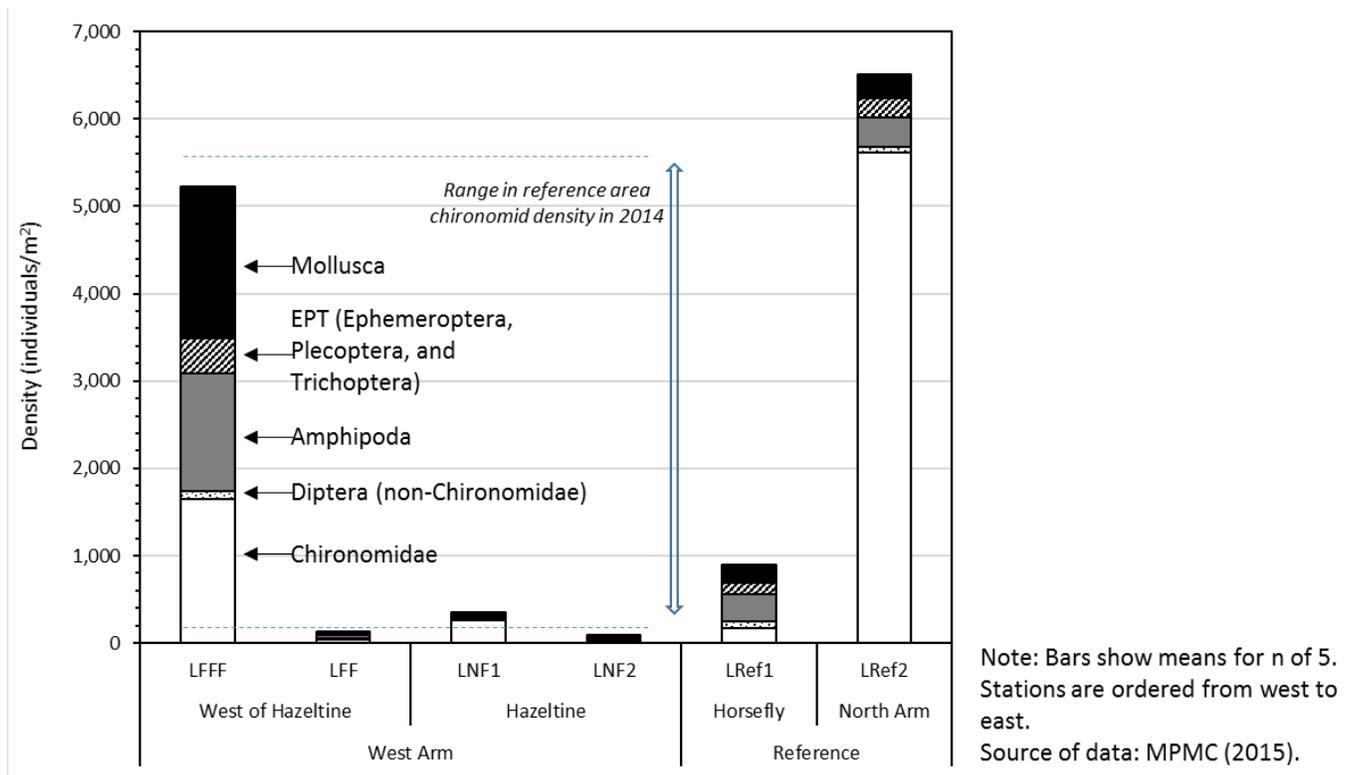
Figure 19: Spatial Variability in Benthic Invertebrate Abundance in the Quesnel Lake Littoral Zone in September 2014

Benthic invertebrate community sampling in September 2014 showed that the density of organisms in the West Arm of the lake adjacent to the mouth of Hazeltine Creek was significantly lower than observed at a reference area in the North Arm of the lake and at a far-field station in the West Arm near the outlet to Quesnel River (Figure 18). Reference areas of the lake were dominated by chironomids, amphipods, molluscs, and EPT taxa and these taxonomic groups were affected primarily in the immediate vicinity of the Hazeltine Creek mouth. The data also show that the density of benthic invertebrates is variable in Quesnel Lake and the degree of effect was variable through the West Arm. For example, chironomid, amphipod and EPT density was lowest at the stations immediately adjacent to Hazeltine Creek whereas the station closest to the Quesnel River had a greater density of chironomids than at Horsefly, suggesting lesser effect there.

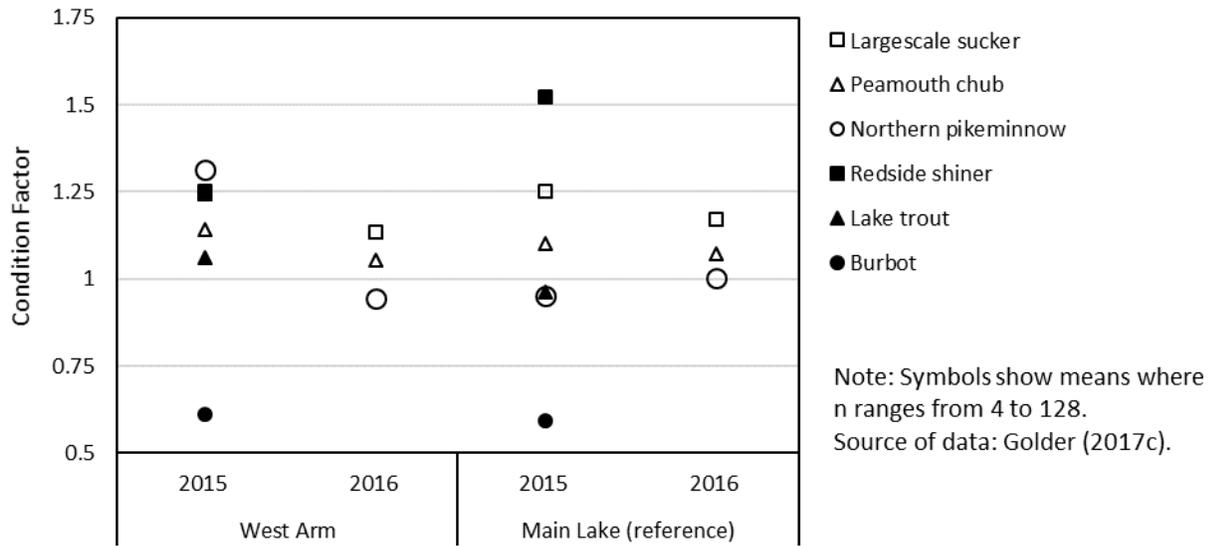
Figure 21: Spatial and Temporal Variability in Condition Factor for Fish Species Potentially Using Littoral Zone Habitat, 2015 and 2016

The actual contribution of the affected area of littoral zone to fish productivity is not known; however, the available data suggest that the decrease in benthic invertebrate prey items have not resulted in a decrease in condition factor of forage fish, Lake Trout, or Burbot captured in the littoral zone (Figure 21).

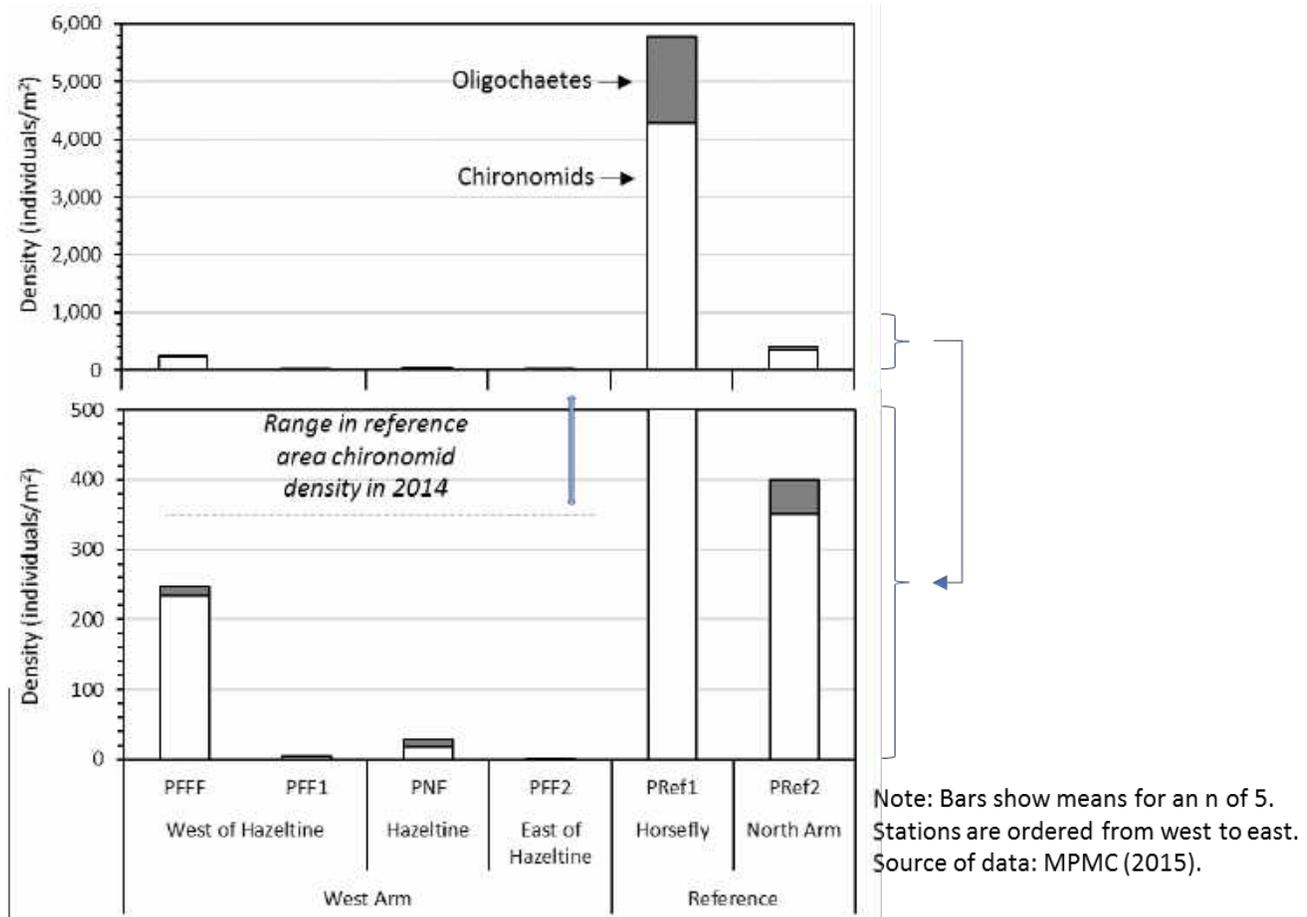
Figure 22: Spatial Variability in Benthic Invertebrate Abundance in Quesnel Lake Benthic Zone in September 2014

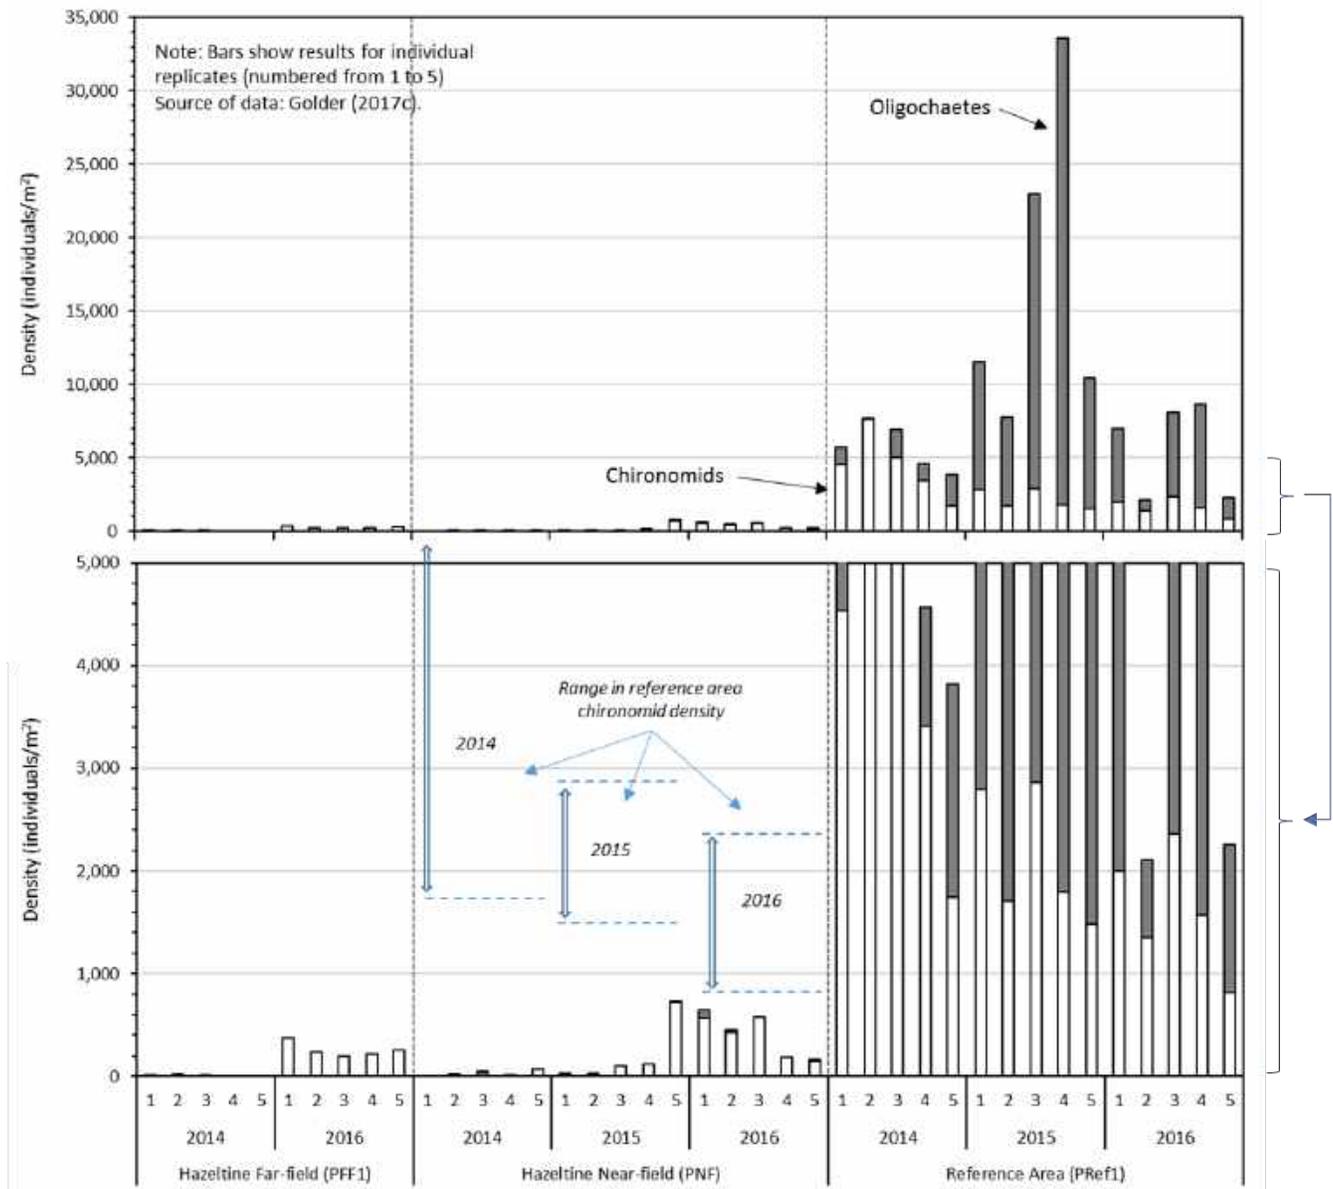
Figure 23: Spatial and Temporal Variability in Benthic Invertebrate Abundance in Quesnel Lake Benthic Zone in 2014, 2015, and 2016

Benthic invertebrate data collected in 2015 and 2016 show that the benthic invertebrate community has started to recover in the vicinity of Hazeltine Creek (Section 3.2.4). Samples were also collected in 2017 but as of the time of writing, results are not yet available. Figure 23 shows the density of chironomids and oligochaetes in individual replicates for the Horsefly reference station and the Hazeltine affected station for 2014, 2015, and 2016. The communities were dominated by oligochaetes and chironomids, and spatially variable at both stations. The significantly higher number of oligochaetes at the reference station in 2015 appears to be related to an influx of tubificids (one of the types of oligochaete worms in that area), potentially from the Horsefly River itself or the shorelines of the lake. Although a positive (increasing) trajectory of recolonization is apparent in the data (Figure 23), those data are based on only three seasons of sampling events and verification of such a trajectory is required. As only three annual sampling events (2014 to 2016) have been conducted to date and in limited areas of the lake bottom, the trajectory of recolonization requires confirmation.

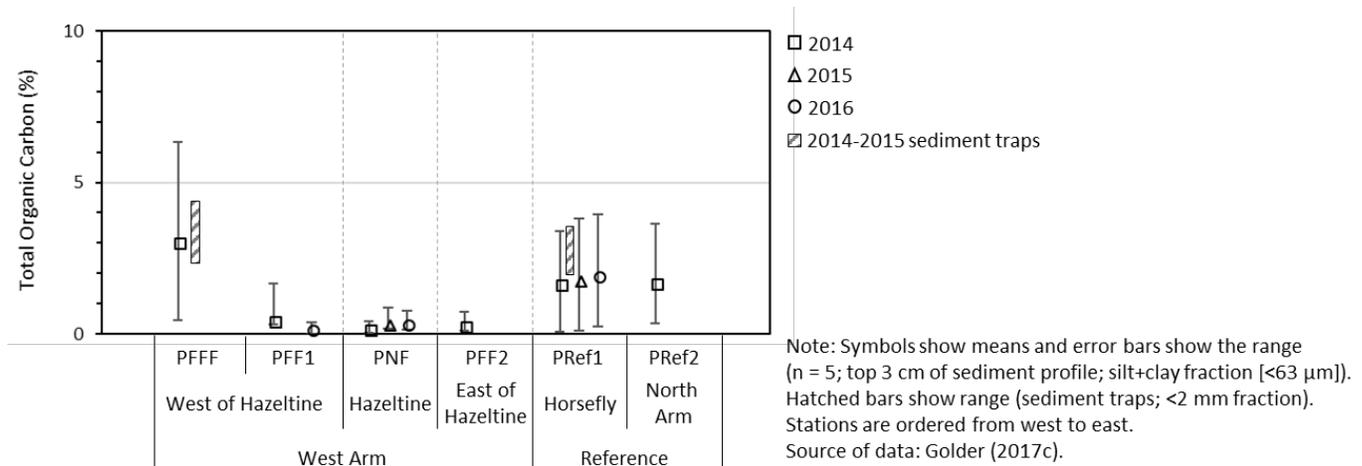
Figure 24: Spatial Variability in Total Organic Carbon in Quesnel Lake Benthic Sediments in 2014, 2015, and 2016

The ERA suggested that the physical structure, more specifically the low organic carbon content of the sediments, is affecting the recolonization of those sediments. In laboratory-based sediment tests, it was found that in low organic carbon sediments dominated by outwash materials that are low in organic carbon, growth was reduced. However, adding organic carbon to those sediments resulted in normal organism growth. Figure 24 illustrates the spatial and temporal variability of total organic carbon (TOC) in the sediments of the West Arm and in reference areas at Horsefly and in the North Arm. In 2014, sediments collected adjacent to Hazeltine had relatively low TOC (<0.5%). Subsequent sampling indicated that TOC was higher in 2015 and 2016, and while not at the average TOC content observed in the reference areas, TOC was within the range of reference samples. Thus, it appears that natural processes are contributing organic carbon to the sediments. This is a reasonable inference based on the TOC content of sediments collected in sediment traps at the West Arm far field station (towards Quesnel River; 2.3 to 4.3%) and the Horsefly reference station (2 to 3.5%) between 2014 and 2015. The increasing TOC in the sediments at Hazeltine could in turn be related to the increasing density of benthic invertebrates observed in the West Arm.

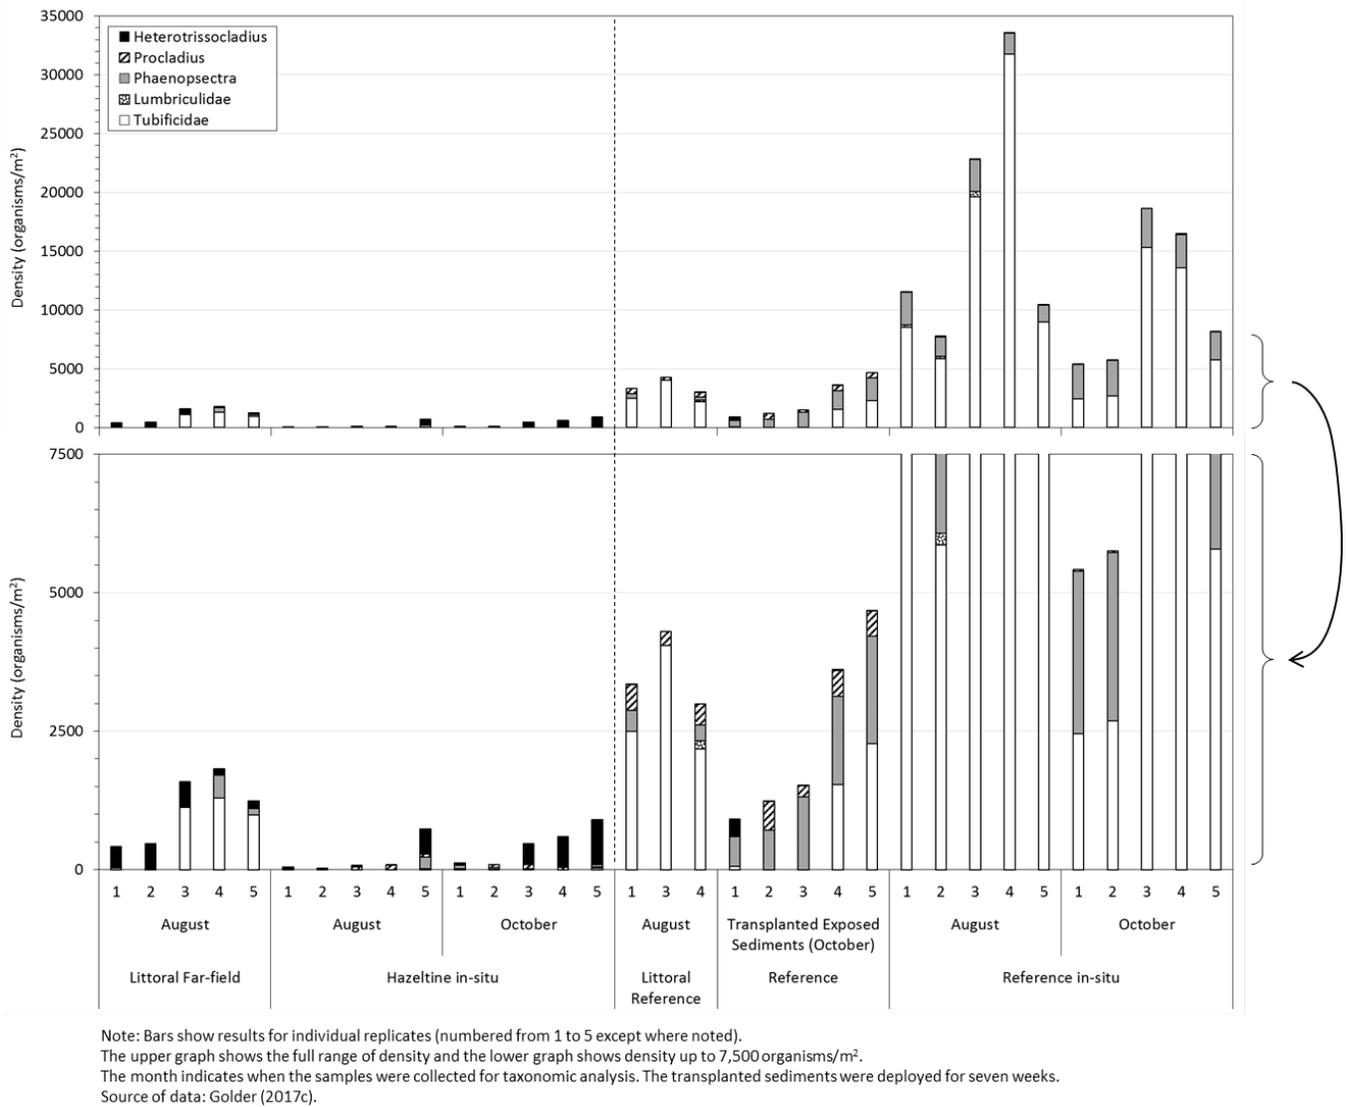
Figure 25: Chironomid and Oligochaete Density in Transplanted and *In Situ* Sediments (2015)

⁷ The sediments were transplanted with and without a carbon amendment. The results for the amended sediments were not significantly different from the un-amended sediments therefore the data for the amended sediments are not shown here.

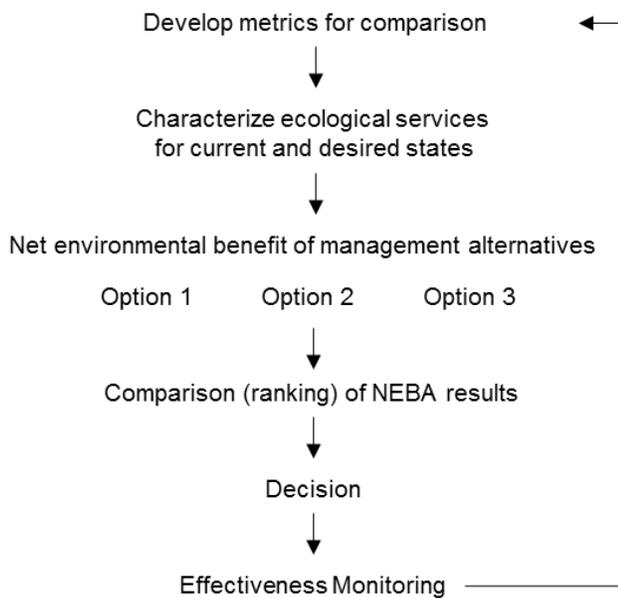
Figure 26: Framework for Net Environmental Benefit Analysis (adapted from Efroymsen et al. 2003)

As a result of physical smothering from the settled breach outwash materials, the environmental services of the lakebed have been disrupted and low organic carbon content has been identified as a potentially limiting factor for benthic invertebrate community recovery. NEBA is therefore, conceptually, a useful tool for identifying and comparing potential management options for addressing the Quesnel Lake remediation area. A framework for undertaking NEBA is illustrated in Figure 26.

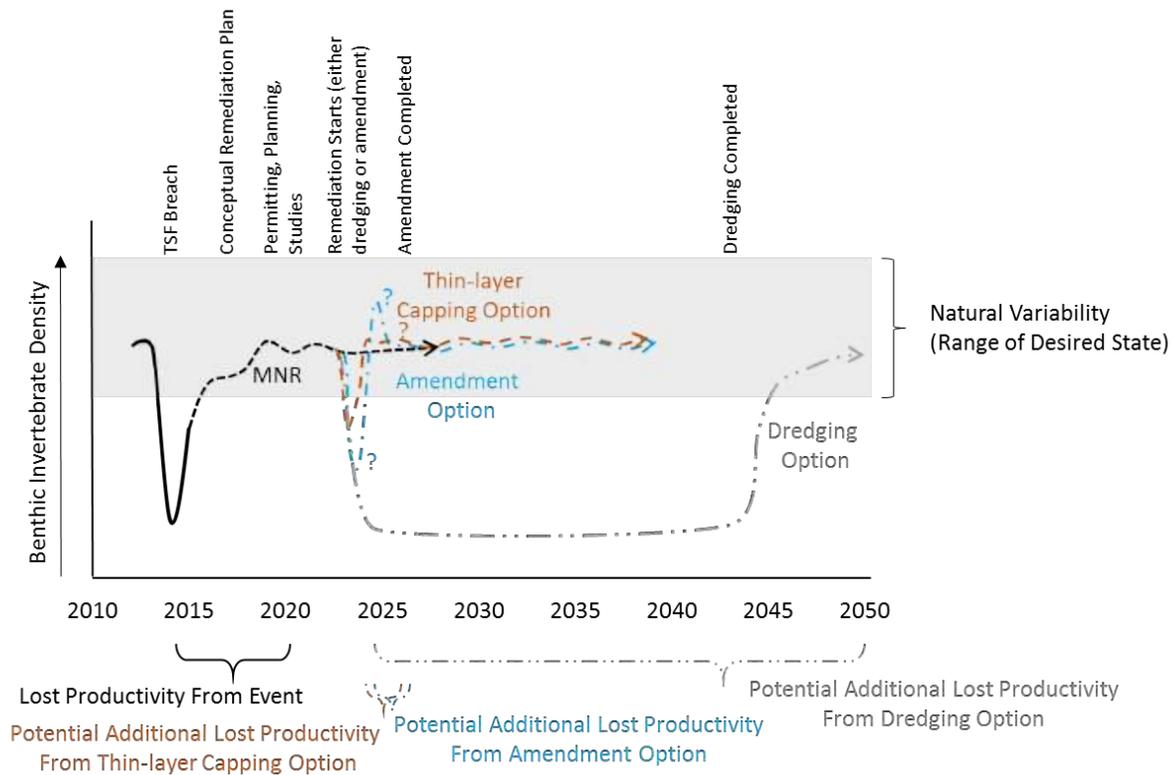
Figure 27: Conceptual Comparison of Influence of Remediation Option on Net Benthic Invertebrate Productivity (Not Based on Actual Data from Quesnel Lake)

It should be noted that Figure 27 is a conceptual figure and the dotted lines are notional projections. It is possible that the impacts of dredging, in particular, could be reduced somewhat through project planning with recovery starting as the dredge works its way across Quesnel Lake. However, given the depth of the design dredge cut being upwards of 10 m, it is possible that such a depth would need to be achieved through multiple passes. A 10 m deep cut would be filled by inwards collapse of the uncut sidewalls and such events would generate turbidity at depth which may be available for surface water turbidity at lake overturn. Therefore, while the absolute losses notionally depicted in Figure 27 may be greater than achievable in a well-designed dredging program, in relative terms, the figure nevertheless depicts the concept of extended duration perturbations to the benthic community should the dredging option be pursued. There is no evidence available to suggest that following dredging, benthic productivity would be higher than it would otherwise be with MNR. Accordingly, dredging scores poorly on net environmental benefits, whether considered in the broad context as described above or in the narrower context of non-human biological metrics.

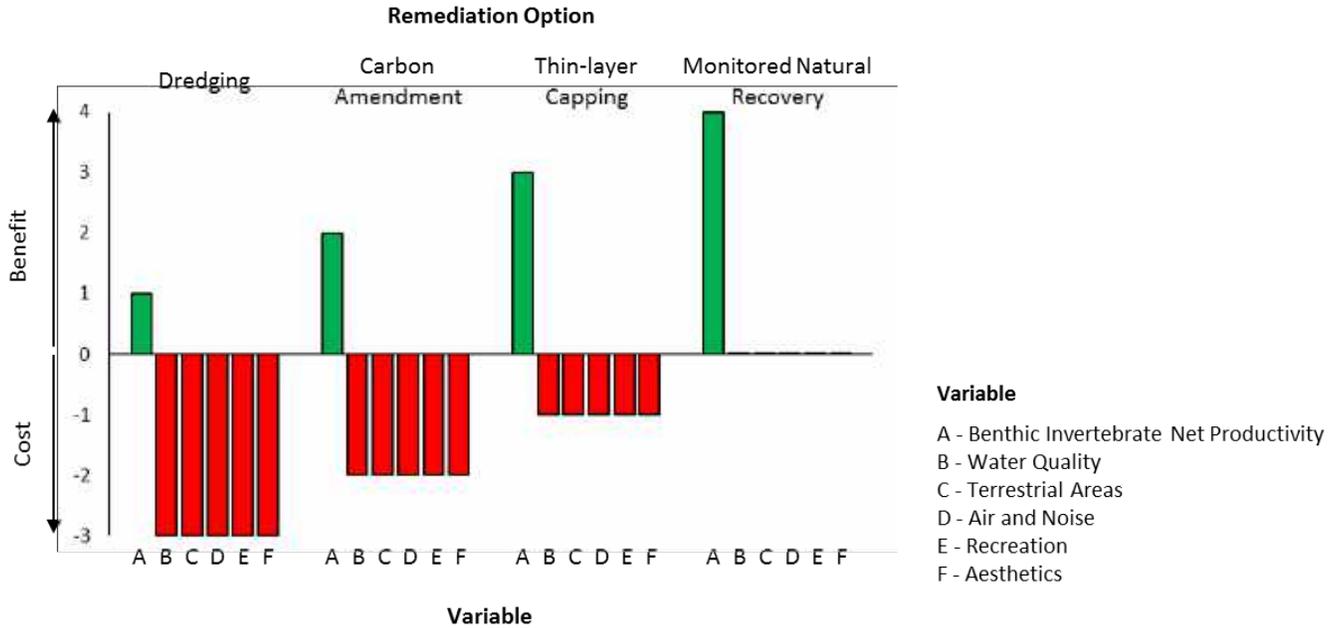
Figure 28: Net Environmental Benefit Analysis of Dredging Versus Carbon Amendment versus Thin-layer Capping versus Monitored Natural Recovery

Monitored natural recovery is expected to result in the greatest net benthic invertebrate productivity and is not expected to cause further environmental effects (beyond those caused by the event itself). As with all three options, performance verification of MNR would be a necessary component of the CEMP.

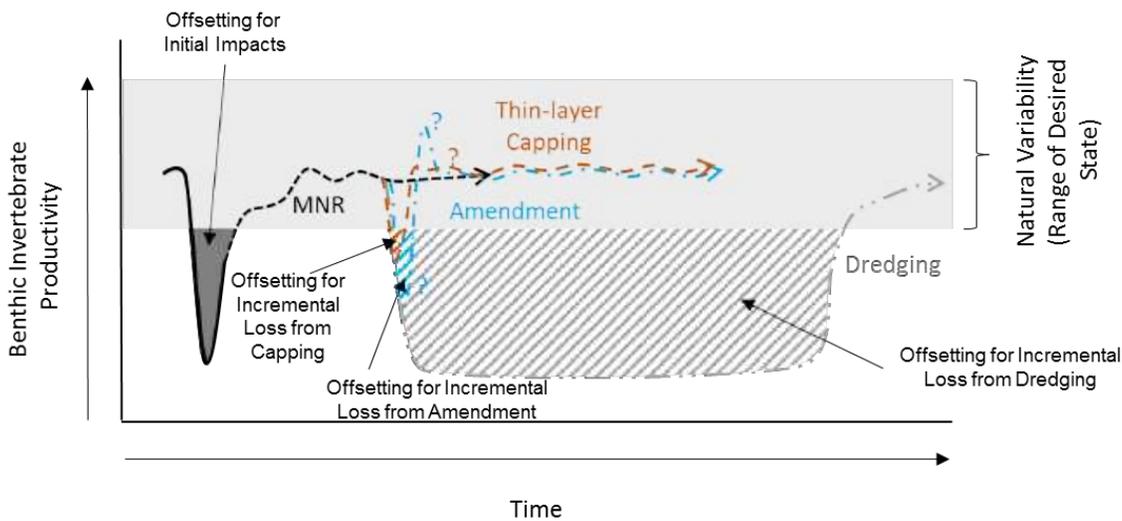
Figure 29: Conceptual Illustration of Offsetting Needs Post-Remediation

Even with the selected remediation option for Quesnel Lake benthic zone remediation (MNR), as a result of the event there was a loss of benthic invertebrate productivity and quantifying that lost productivity is part of the objective of identifying and quantifying productivity offsets. Figure 29 illustrates the conceptual offsetting requirements for the initial impact with MNR (and other options). Estimated remediation duration for MNR is approximately 5 years based on estimates from literature plus a reduced rate of colonization in year one as turbid materials were settling out. There is uncertainty in this estimate. Residual impacts and offsets for Quesnel Lake are discussed in Section 5.4.2.
