Mount Polley Mining Corporation
an Imperial Metals company
Box 12 | Likely, BC V0L 1N0
T 250.790.2215

Community Update

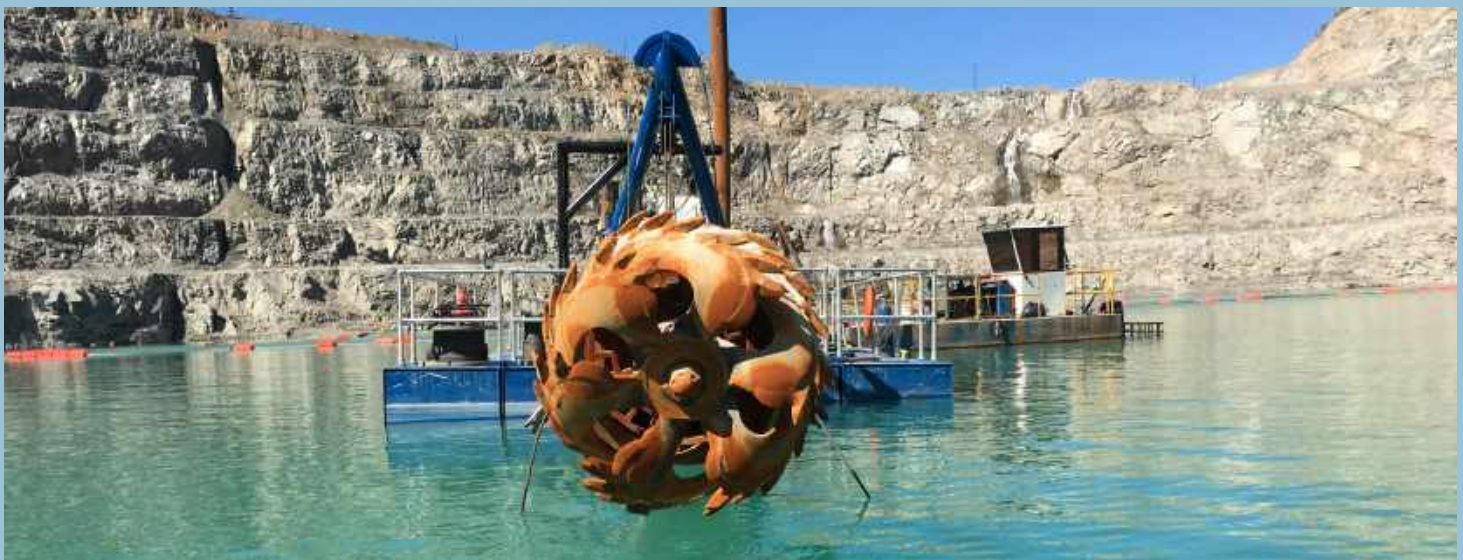
The cutting head for the dredge is used to cut and agitate the materials before being sucked into the dredge and pumped to the TSF.

Dredging of tailing materials in the Springer Pit finished at the end of October. MDG Contracting Services is demobilizing their 2 dredges. Dredged tailings were delivered via pipeline to the tailings storage facility (TSF).

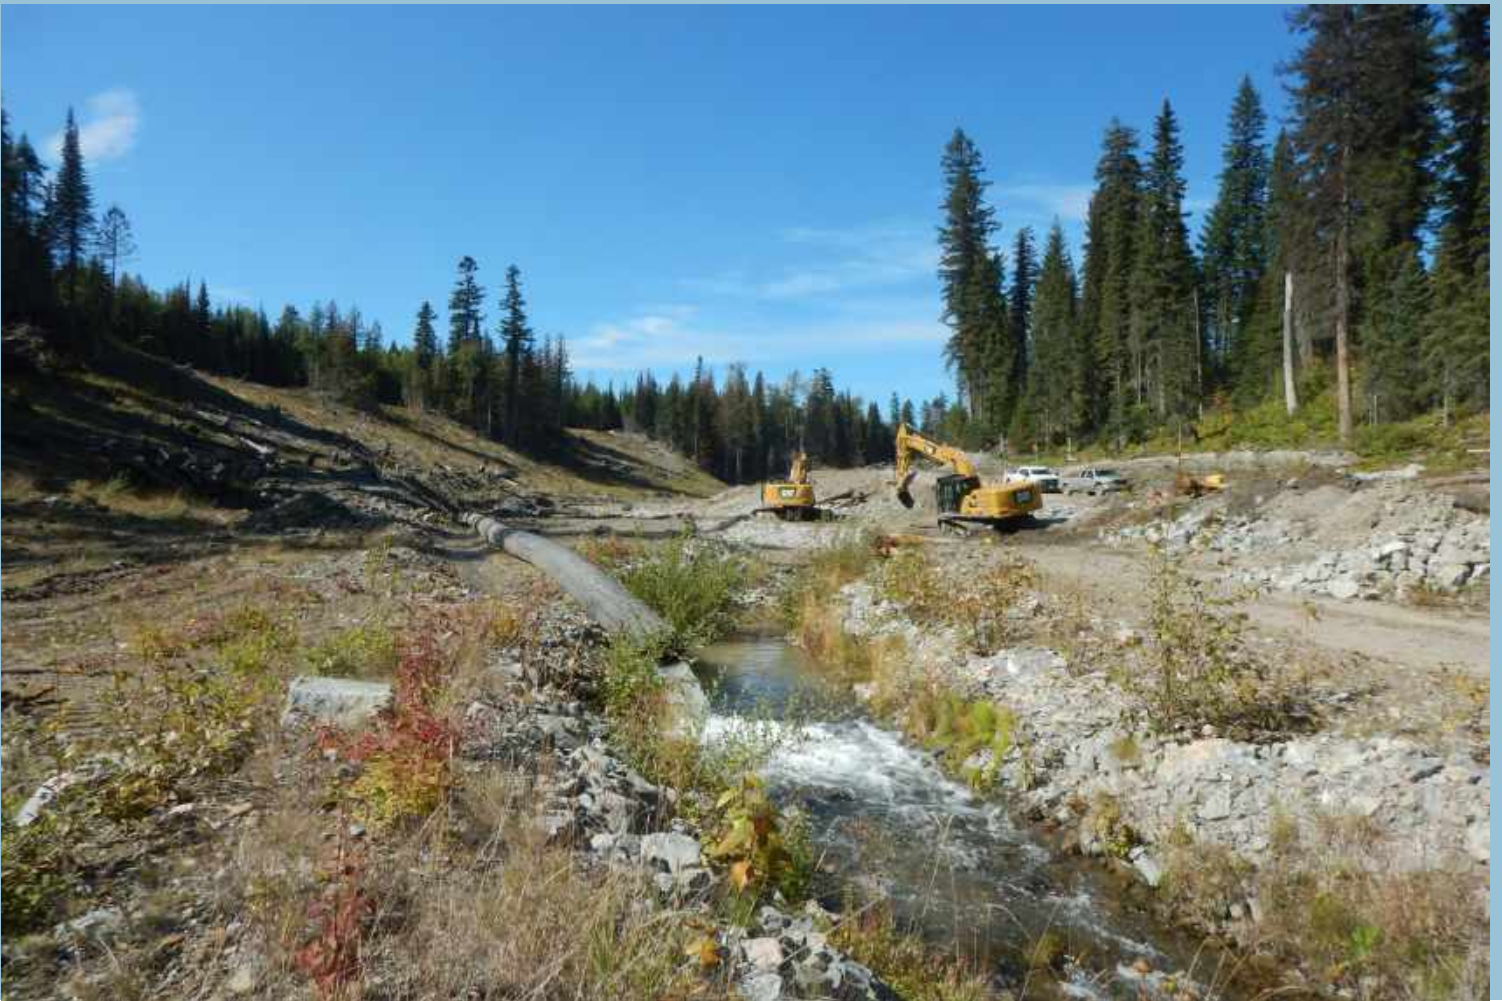
Construction in Hazeltine Creek continues. In order to dewater the worksite a bypass is used to divert the flow of water around the worksite, shown here.

Remediation efforts continue in the areas affected by the tailings dam breach. In 2019, ~119,000 seedlings were planted in the riparian and upland areas adjacent to Hazeltine Creek. The creek construction continued in Reach 3 with channel realignment, habitat features and lower floodplain/riparian habitat. By the end of the 2019 construction in Reach 3 will be completed. Seed collection and ground cover seeding is planned for this fall and early 2020 in areas disturbed by the construction in 2019. Final design work is being completed by Golder Associates and Envirowest for the remaining channel work to be completed in lower Hazeltine and Edney Creeks. The final design will include decommissioning of the sedimentation ponds and conjoining the two creeks close to where they historically met. Remediation work is expected to continue in 2020 with work planned for completion in the Lower Hazeltine Creek area.

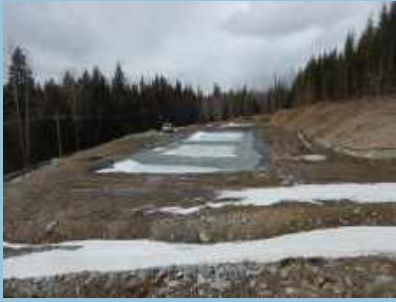
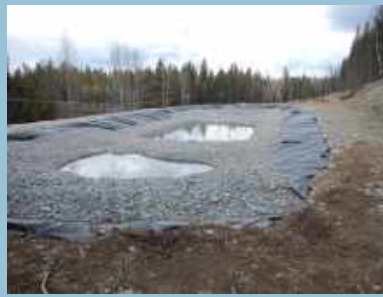
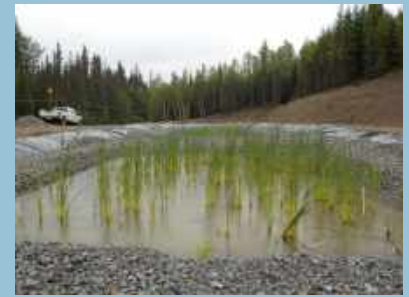
An on-site pilot scale constructed wetland treatment system was installed in late 2018 at the mine to explore options for treatment of water by passive means during mine operations and closure. The wetland has been developing its vegetative and microbial communities and progressing towards commissioning. The plant community is very select and undesirable plant growth is removed. The wetlands at Mount Polley contain primarily cattails and aquatic mosses. The first sets of water chemistry samples were taken in Q3 of 2019, the results are pending. There are some parameters that have not yet been met in order to declare the wetland operational, mainly dissolved oxygen in the water column. As this is a newly constructed wetland, the conditions within the wetland sediments are not yet anoxic enough due to a lack of decomposing materials.

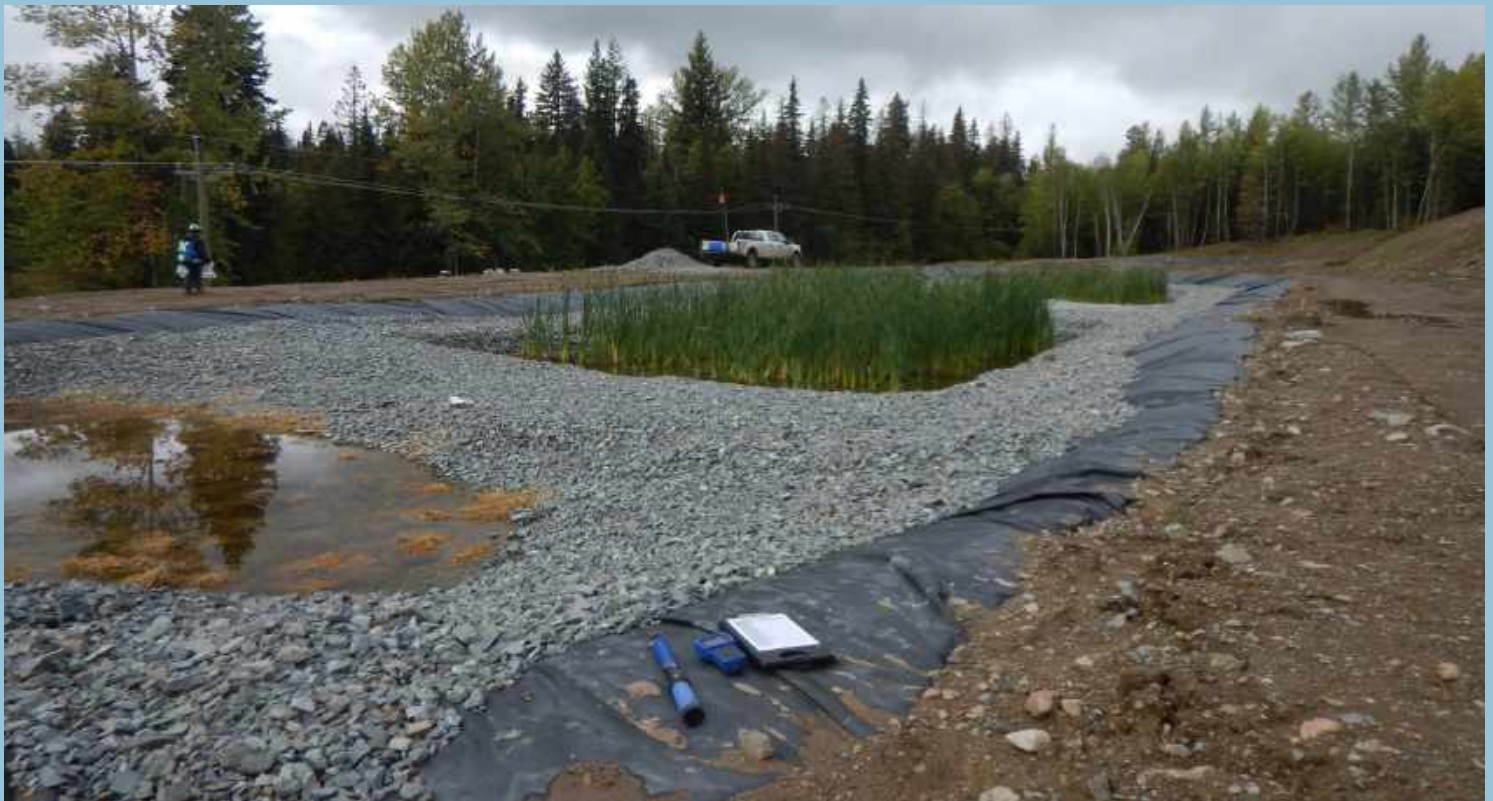
The Constructed Wetland Treatment System at Mount Polley Mine is composed of 3 Series, each with 2 cells of differing characteristics all being fed by the same source water. This photo shows the forebay of Cell 2A full of straw, used to accelerate the reducing process..
