MOUNT POLLEY MINING CORPORATION POST-EVENT ENVIRONMENTAL IMPACT ASSESSMENT REPORT – KEY FINDINGS REPORT

JUNE 5, 2015

Golder Associates Ltd.
Suite 200 - 2920 Virtual Way,
Vancouver, BC, V5M 0C4

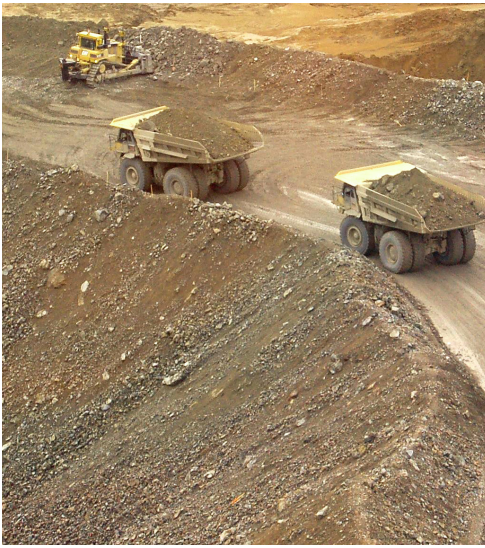
Haul trucks lined up to build a rock berm to hold back tailings in the TSF so that the breach could be repaired safely

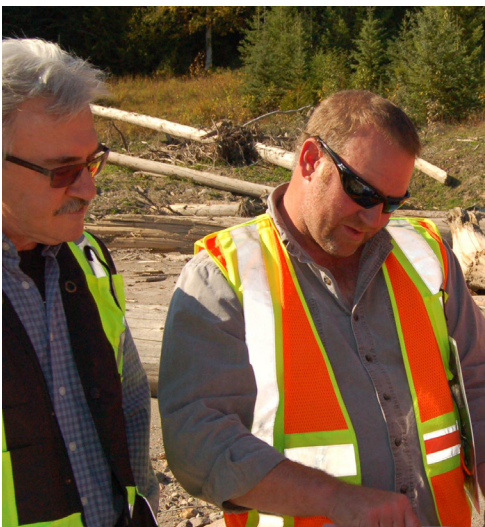
As soon as Hazeltine Creek could be safely accessed, construction works to control erosion were initiated

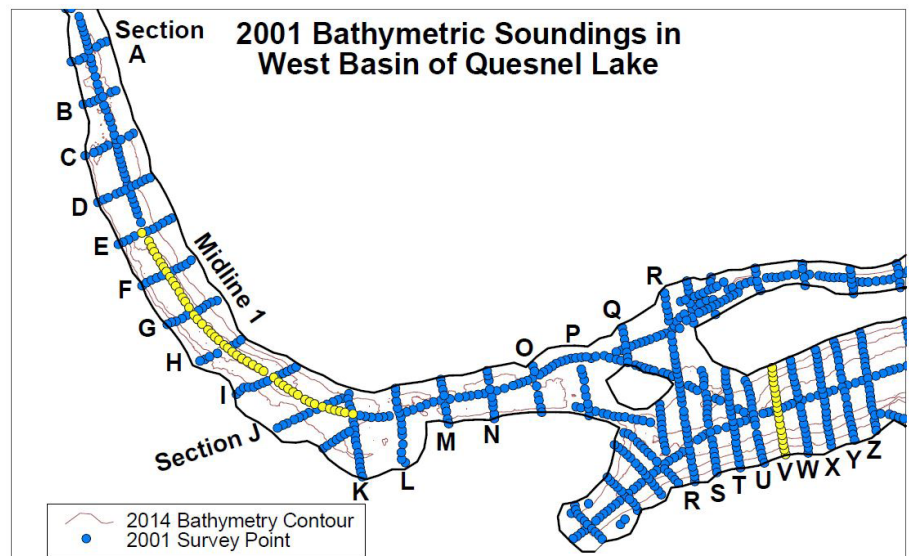
Figure 5: Lake depth profiles (bathymetry) collected in 2001

- Multi-beam Sonar was used to develop a depth profile of the bottom of Quesnel Lake in September 2014 and that was compared with spot measurements of lake depth carried out in 2001 (Figure 5 and Figure 6).
- Sub-bottom profiling is used to identify and characterize layers of sediment or rock under the lake bed. Layers of sediment or rock provide different reflections in the profiles and these can be used to identify areas where sediments have settled. This information was used together with the multi-beam sonar data to estimate where sediments have deposited on the bed of Quesnel Lake (Figure 7).
- A water level gauge, operated by the Water Survey of Canada is located on Quesnel Lake. The gauge recorded a sudden rise in the lake level on August 4, 2014 (Figure 8). By examining the lake level

Using this information, Tetra Tech EBA estimated that 18.6 ± 1.4 million m³ entered Quesnel Lake. The breakdown of that material is shown in Figure 9. Most of this material deposited deep in the West Basin, below 100 m depth. The area of that deposit was estimated to be approximately 1.81 km². In some places the deposited material was estimated to be up to 10 m thick; however, those estimates were done soon after the spill and that depth is expected to decrease as the sediments consolidate/dewater/compact with time. For Polley Lake, the pre-tailings dam failure data does not allow an interpretation of post breach data.

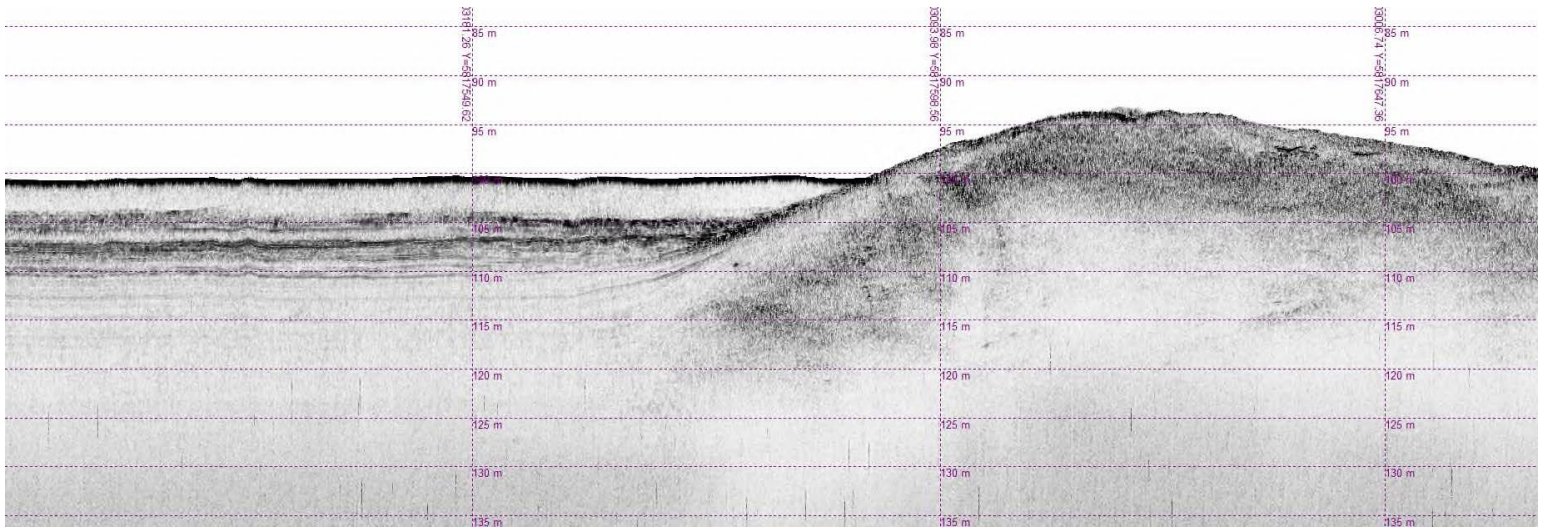
Figure 7: A sub-bottom profile image of Quesnel Lake showing fine-grained sediments on the lake bed along the flat section of the image and showing an underwater lake sideslope on the rise to the right of the image.

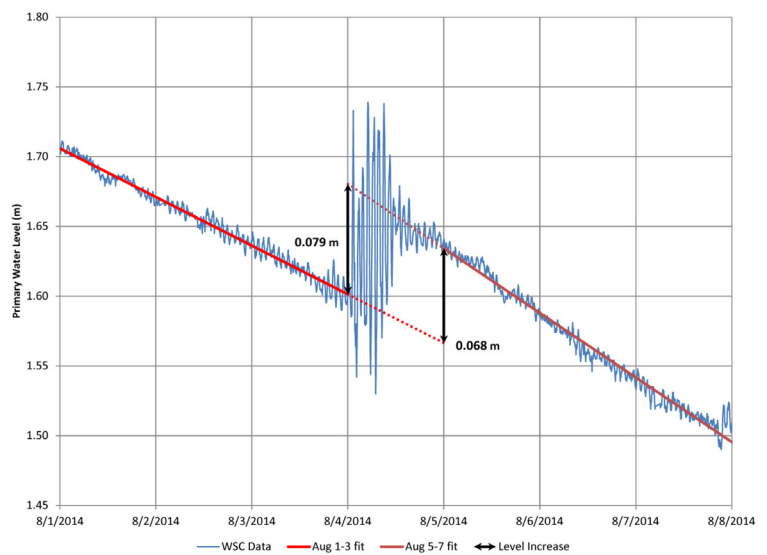
change (68–79 cm) and knowing the surface area of the lake (267.5 km²), the lake volume was estimated to have increased 19.7 ± 1.5 million m³.

Figure 8: Water level of Quesnel Lake near Likely, early August 2014, showing rise in lake level

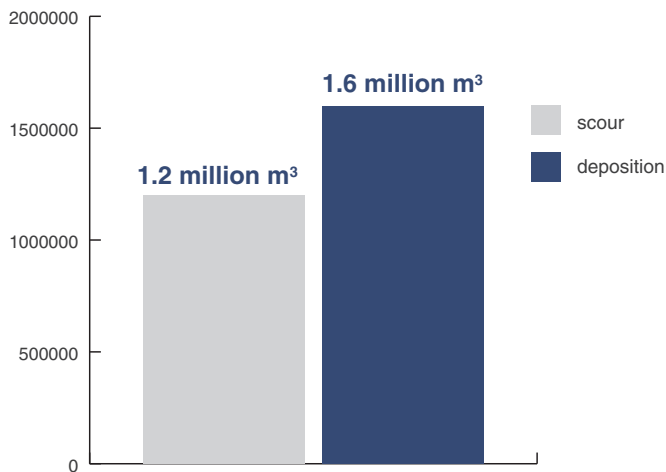
Figure 10 is a simple graphic showing the extent of eroded material and deposited material along the Hazeltine Creek Channel. The deposition occurred primarily near Polley Lake, and the erosion occurred predominantly in the middle reaches of Hazeltine Creek. The debris flow carved a new valley, wider and deeper, along the entire length of Hazeltine Creek by removing sediments from the creek bed, and soil and forest from the floodplain.

Figure 10: Hazeltine Creek tailings/soil deposition*

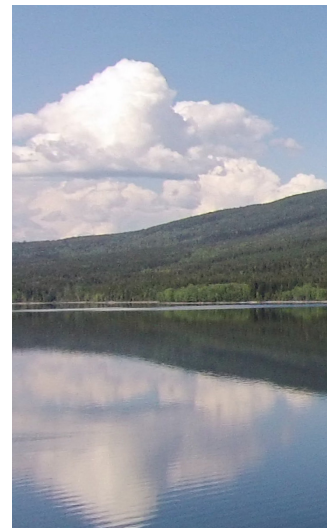
An August 2014 photograph of Hazelmine Creek showing the location of outflow that sank to the deeper parts of Hazelmine Creek, leaving a mostly clear Quesnel Lake surface until fall turn over

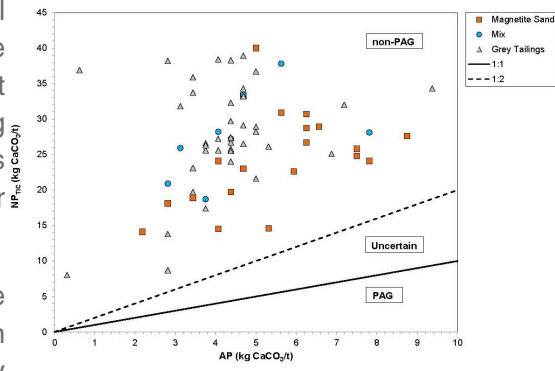
Figure 13: Acid rock drainage (ARD) potential is assessed using neutralization potential ratios

All of the samples collected along Hazeltine Creek showed very low potential for ARD.

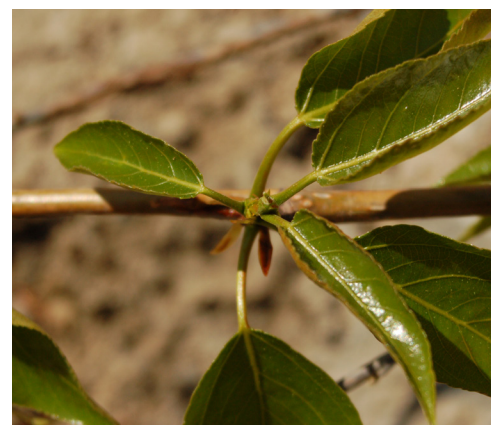
Vegetation planted in lower Hazeltine Creek shows early signs of successful growth

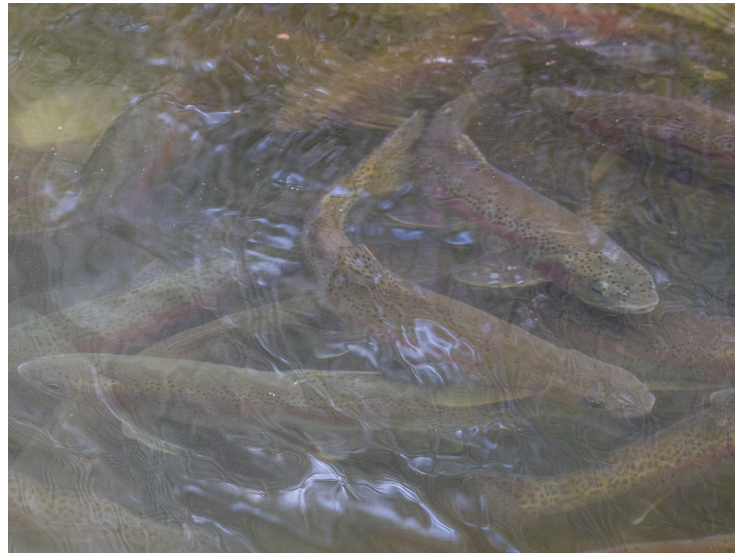
Rainbow trout gathering at the fish fence at the outlet from Polley Lake to Hazeltime Creek in spring 2015

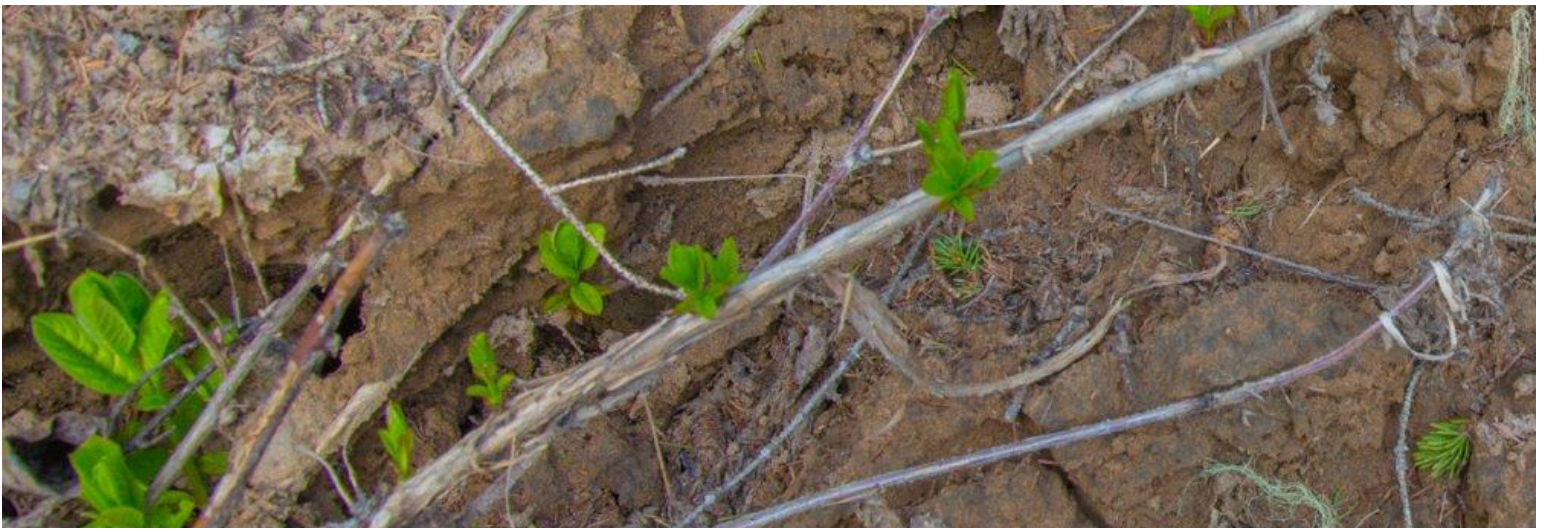
In the meantime, there were signs of new growth in some areas where tailings were deposited and willows planted as part of the Hazeltine Creek restoration work have sprouted indicating that an adaptive succession has begun. The recovery of a healthy plant community will continue to be monitored.

New growth in the tailings impacted area along Hazeltine Creek - Apr 21, 2015.

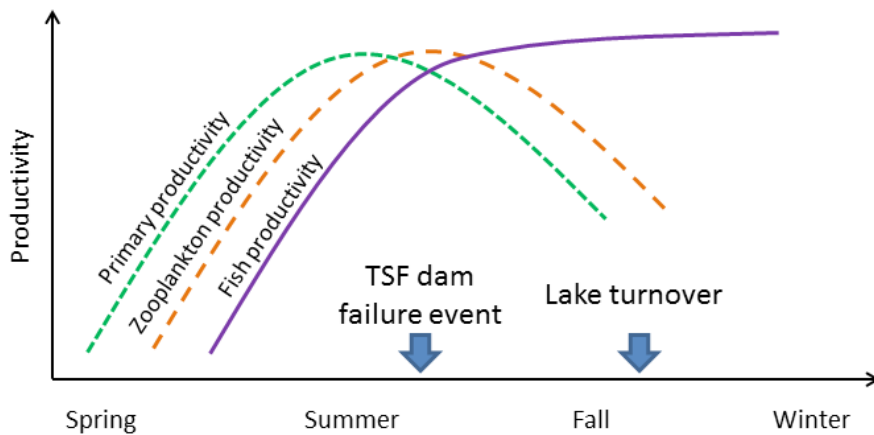
Figure 18: A conceptual lake productivity model under normal conditions showing rise of populations and, after a lag time, rise of their consumers' population/size

Figure 18 shows a generalized conceptual diagram of the dynamics of lake productivity starting in the spring. As the days become longer, the intensity of light energy becomes greater and water temperatures begin to warm, phytoplankton, which are the single-celled small plants the live freely in the water column begin to grow and multiply. The phytoplankton are grazed by zooplankton which begin to increase in size and number as their food supply becomes greater. The zooplankton are eaten by fish, which grow. By late summer and into fall, the phyto- and zooplankton begin to decrease in number as light energy begins to decrease and as fish prey on the zooplankton. The TSF dam failure occurred in late summer; however, because the debris flow was denser than the lake and it sank to the bottom below the zone where light significantly penetrates, the impact on phytoplankton may have been less than had it happened at a different time. When the lake overturned in fall, the cloudy water would have been capable of decreasing photosynthesis by reducing light but this happened in mid-November (winter) when photosynthesis is reduced because of lower light availability and colder water temperatures.

The debris flow would have also brought added nutrients to the lake in August and these nutrients, which are naturally low in Quesnel Lake would allow a larger crop of phytoplankton to grow. While studies carried out did not indicate a larger population of zooplankton based on individual “grab” samples, data provided by Fisheries and Oceans Canada did identify a notable increase in size and abundance of juvenile sockeye salmon. Their size may indicate that nutrients washed into the lake could have increased their food supply.

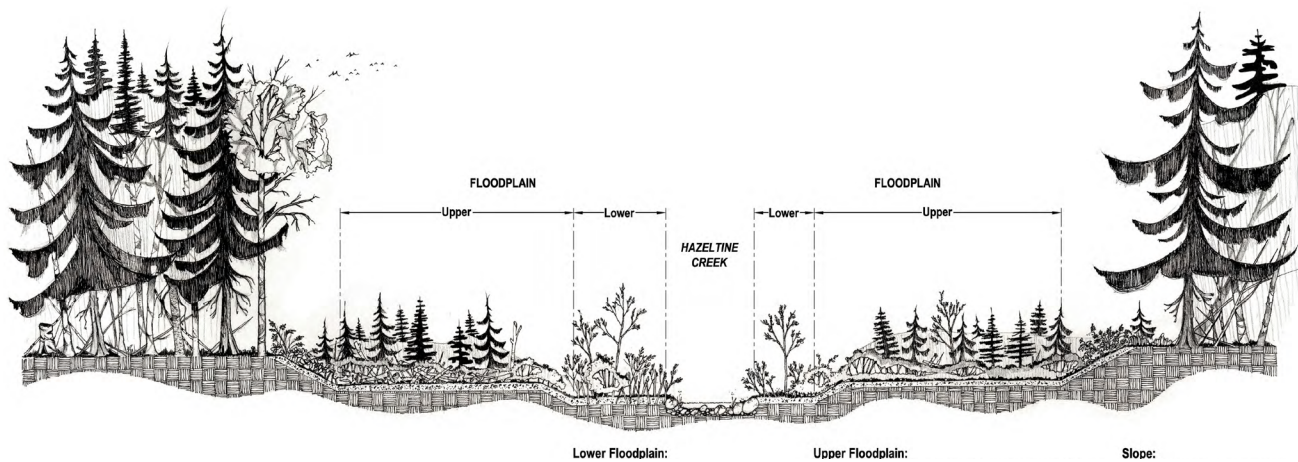
Figure 19: Conceptual channel cross section after five years (Envirowest, 2015)

With this in mind, the engineering design of Hazeltine Creek included a number of key steps. First, a landscape assessment was conducted to evaluate the natural slopes and physical characteristics of the original creek and provide guidance for the channel reconstruction and design. Next, an assessment of water flow volumes was conducted so that the high and low flows of the creek could be accommodated. These elements were put together so that the design will accommodate water flow during peak flows, but maintain sufficient water for trout and other wildlife during low flows. A cross section of the final Hazeltine Creek conceptual habitat design (shown five years after completion) is shown below.

In the meantime, MPMC's skilled equipment operators and crew have been working with river engineers and biologists to rehabilitate Hazeltine Creek. The design for the restoration of Hazeltine Creek focussed on both the construction of a stable channel for water flow, and the restoration of suitable habitats for fish and wildlife. The overall objective for the restoration of fish habitats is primarily to restore trout spawning and rearing habitat in upper Hazeltine Creek and also for Coho and Sockeye salmon in lower Hazeltine Creek. The creek was also designed to restore habitat for wildlife associated with small streams and shoreline environments.

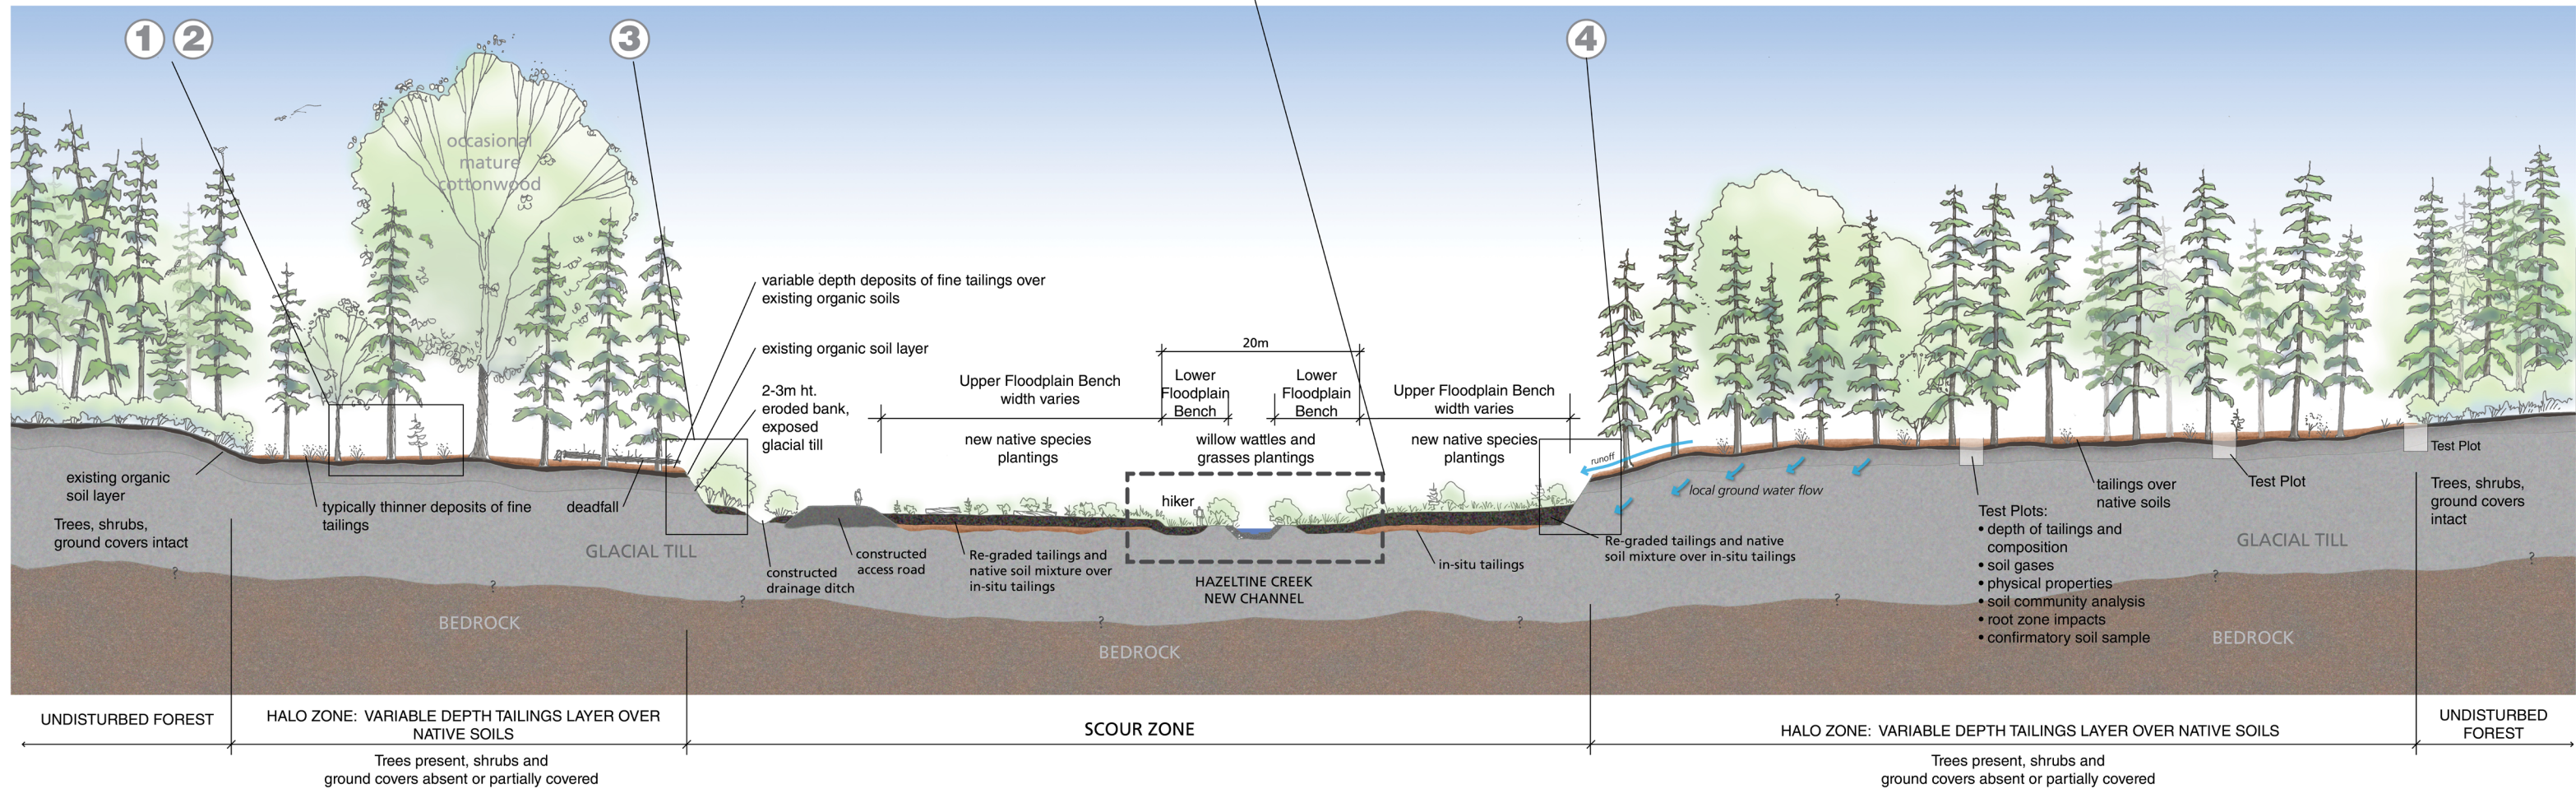
CONCEPTUAL SITE EXPOSURE MODEL (CSM)

This process has been started and is reflected in the Conceptual Site Exposure Model (Figure 20). A sampling and analysis plan to obtain the data needed to understand contaminant exposure and potential effects has been started. The results from the long term tests, for example, the geochemistry test results that we not yet available at the time of writing the PEEIAR, will be incorporated into the risk assessment. Essentially, the Human Health and Ecological Risk Assessment will pick up from where the PEEIAR left off, adding data to support a longer term assessment of risk to both people and the environment.
